# **Investigation and Mitigation Report on Incident Occurring at**

**125 CROWN TERRACE**

**December 16, 2013**

**Tom C. Hui, S.E., C.B.O.**

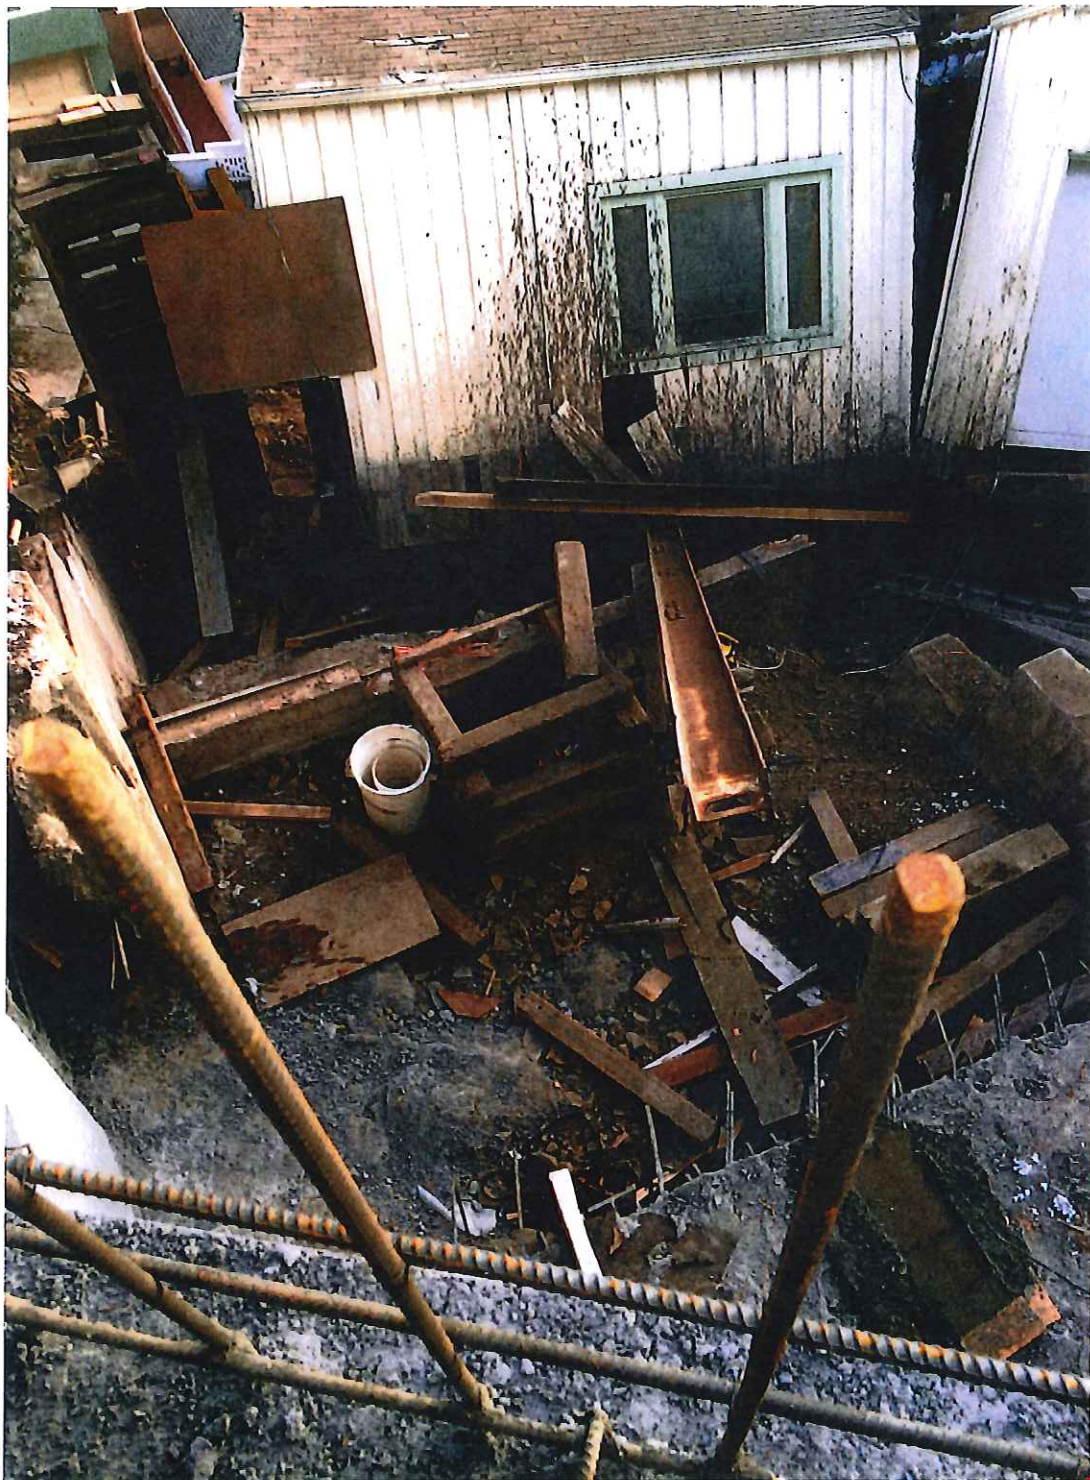
Figure 1: Collapse of Structure from Crown Terrace

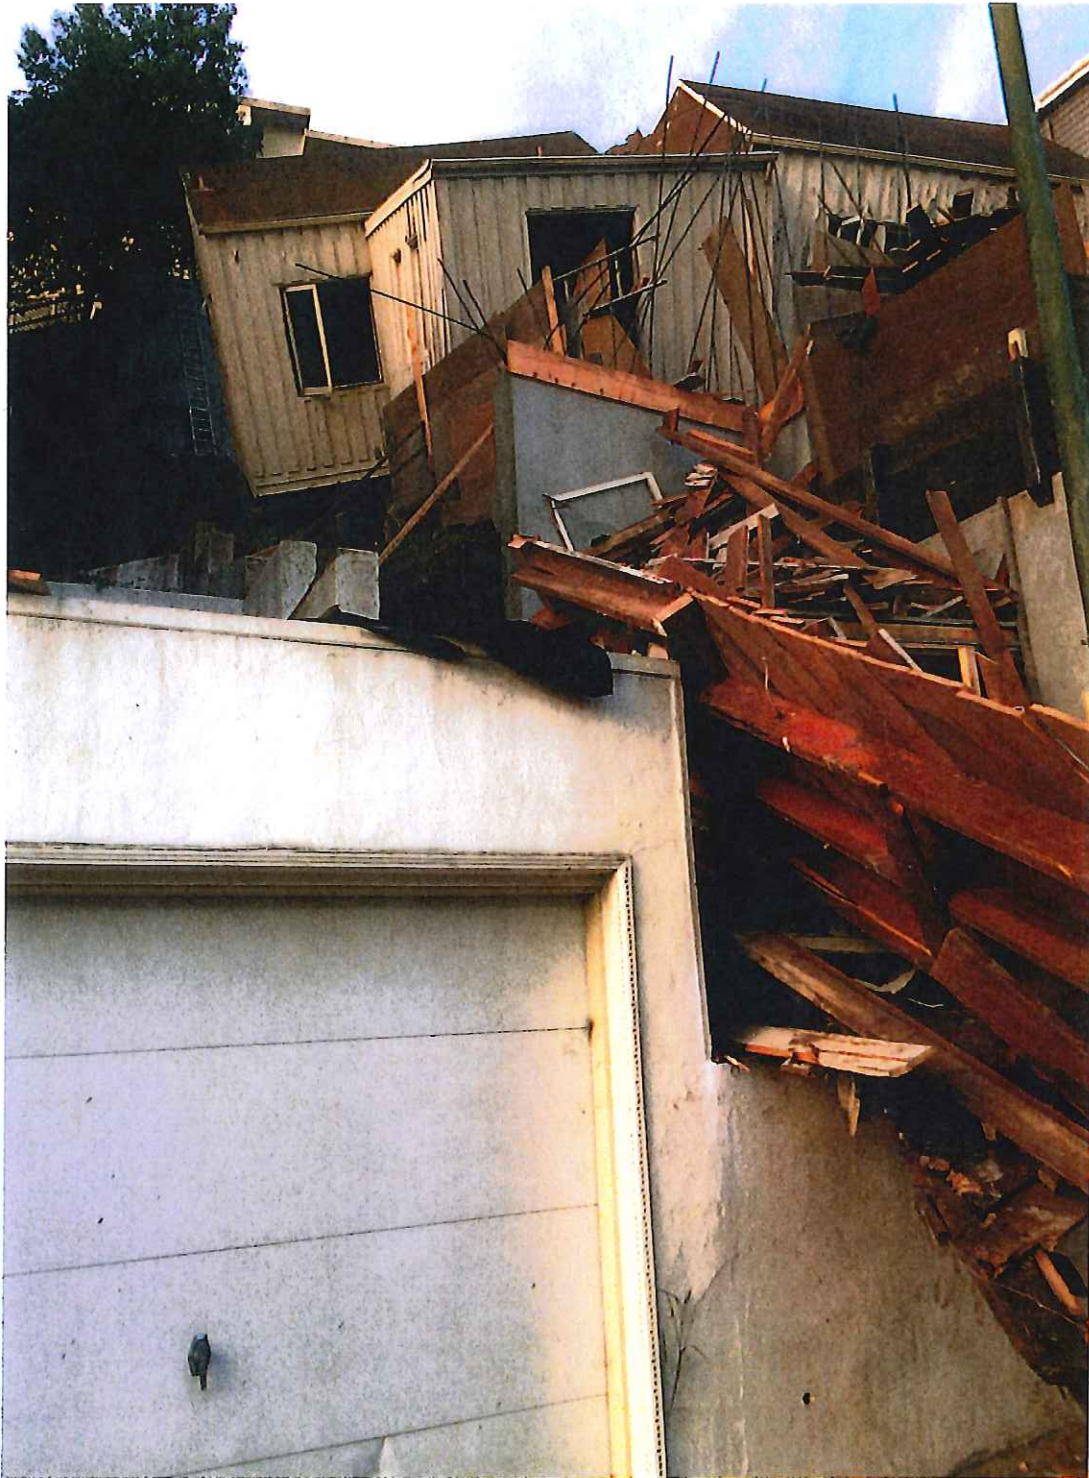
Figure 2: Collapse of Structure from Graystone Terrace

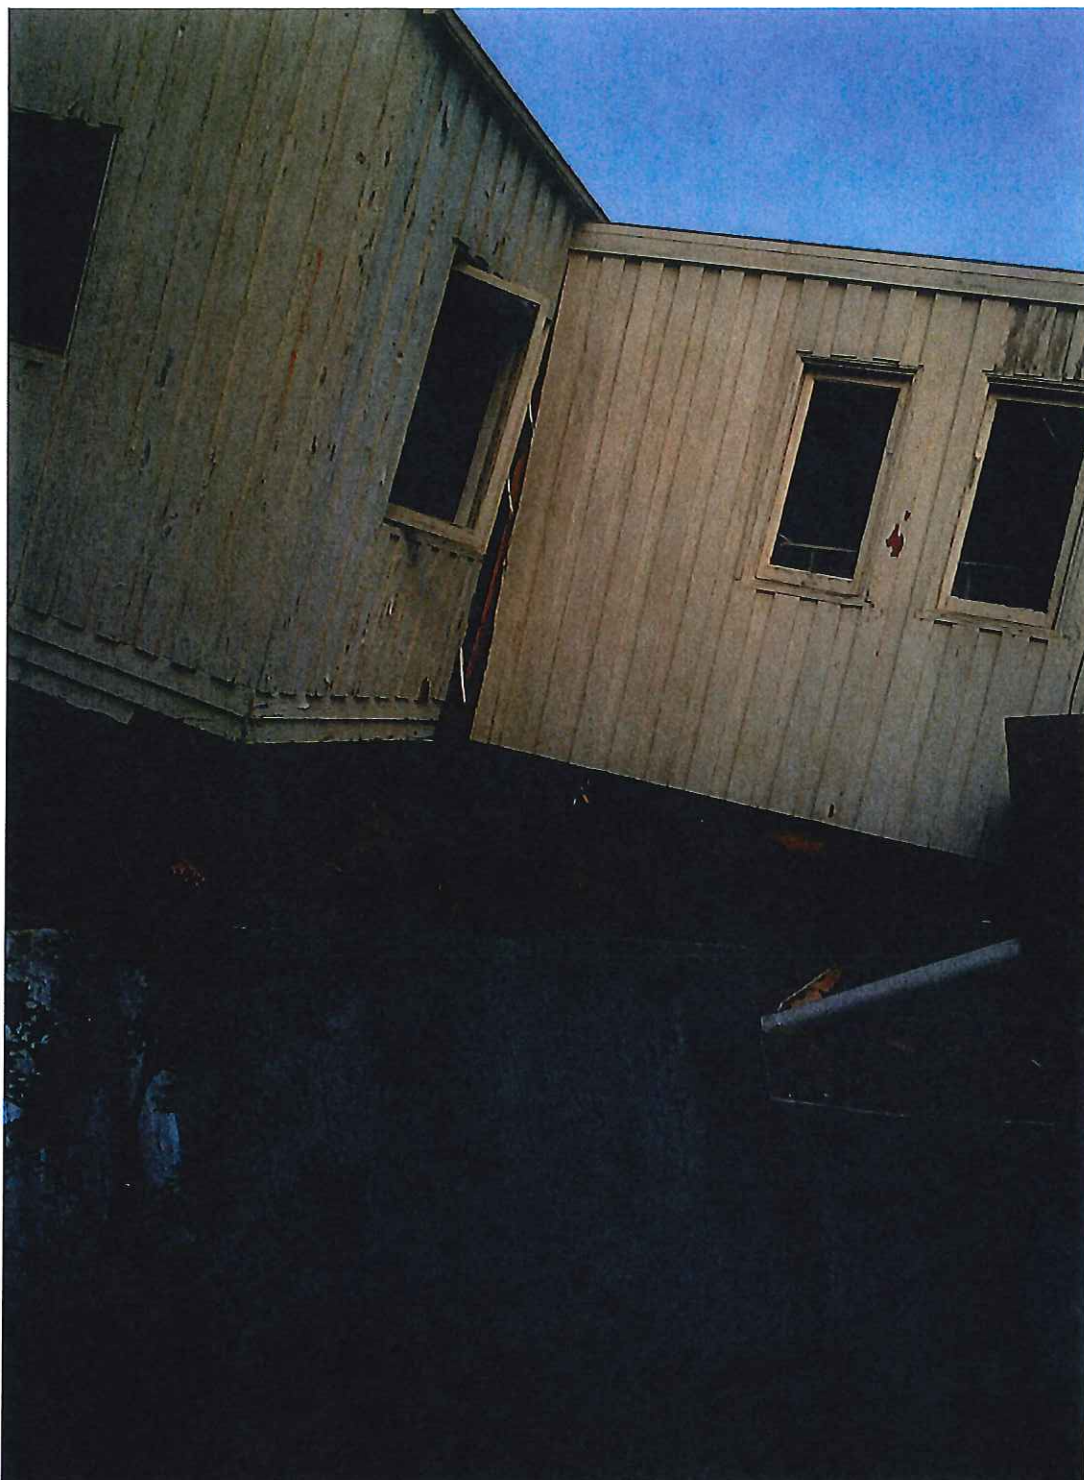
Figure 3: Collapse of Structure on Southside

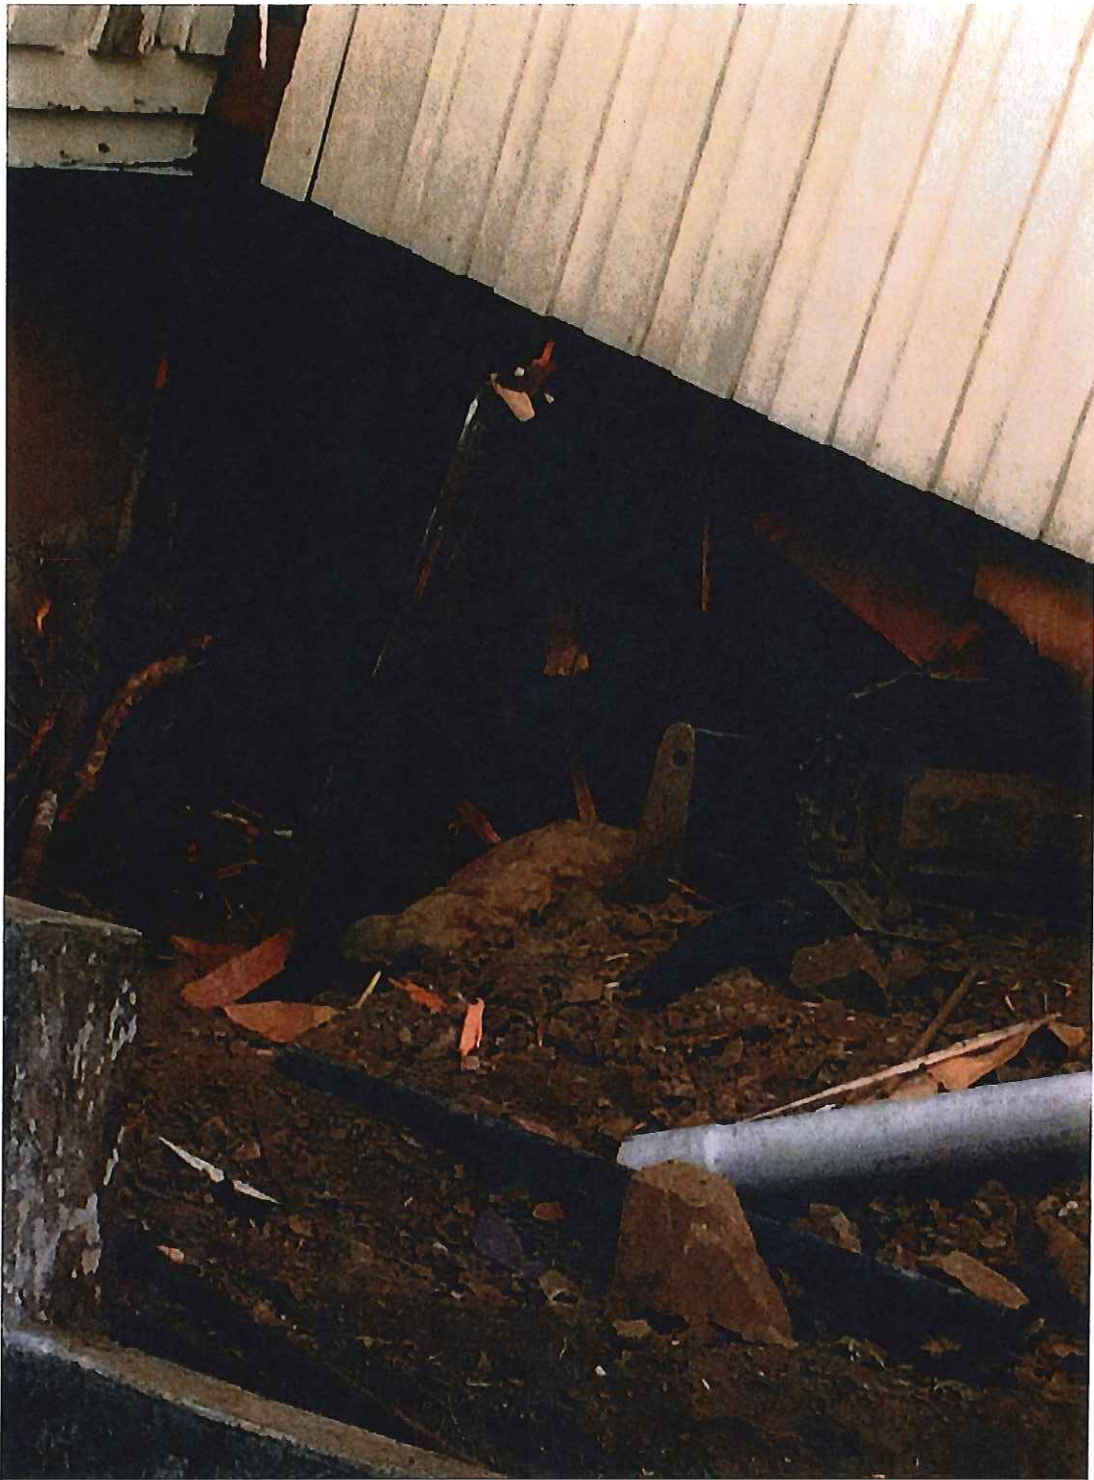
Figure 4: Collapse of Structure on Southside

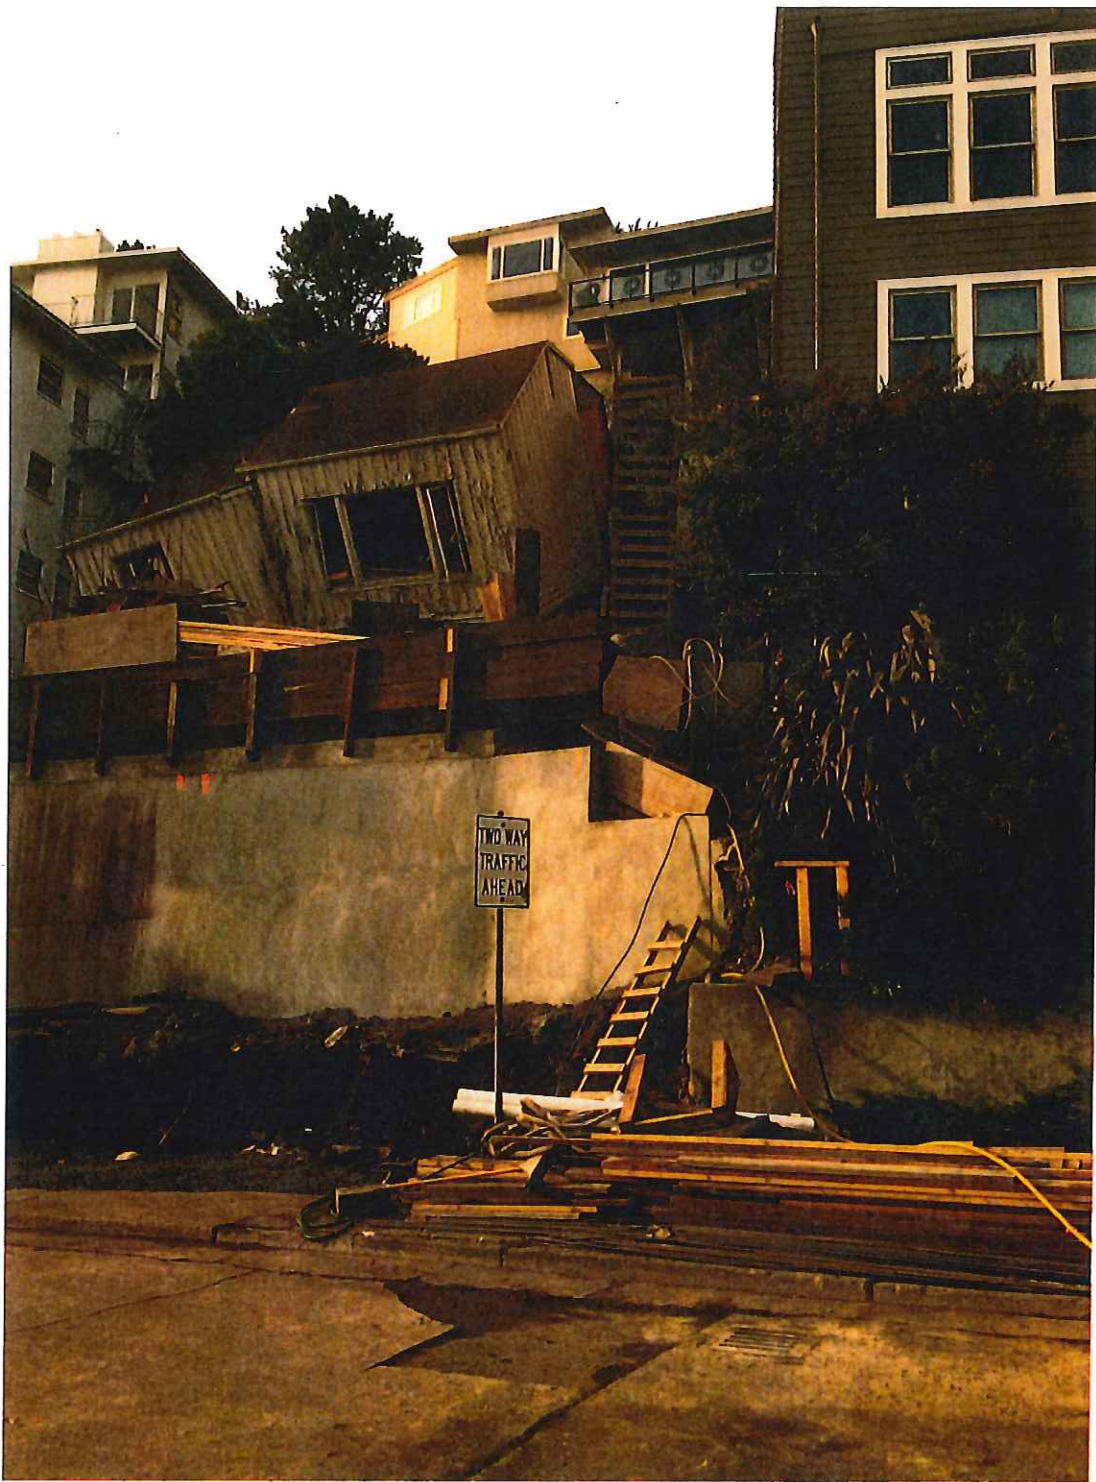
Figure 5: Collapse of Structure from Graystone Terrace

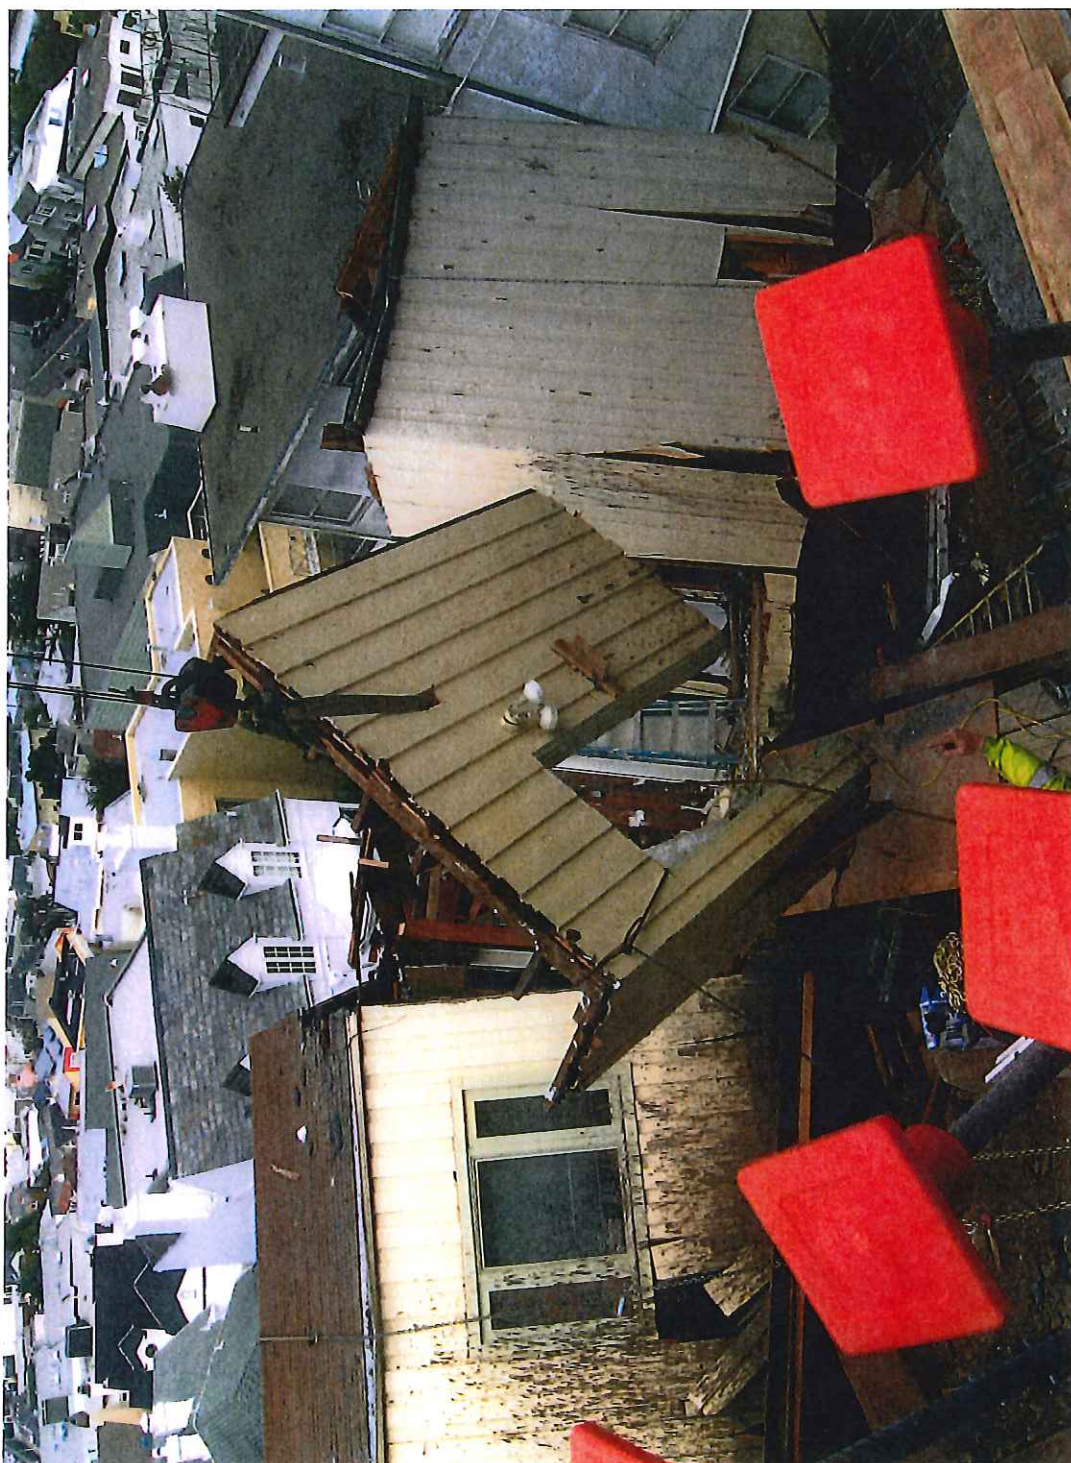
Figure 8: Removal and Retention of Exterior Walls

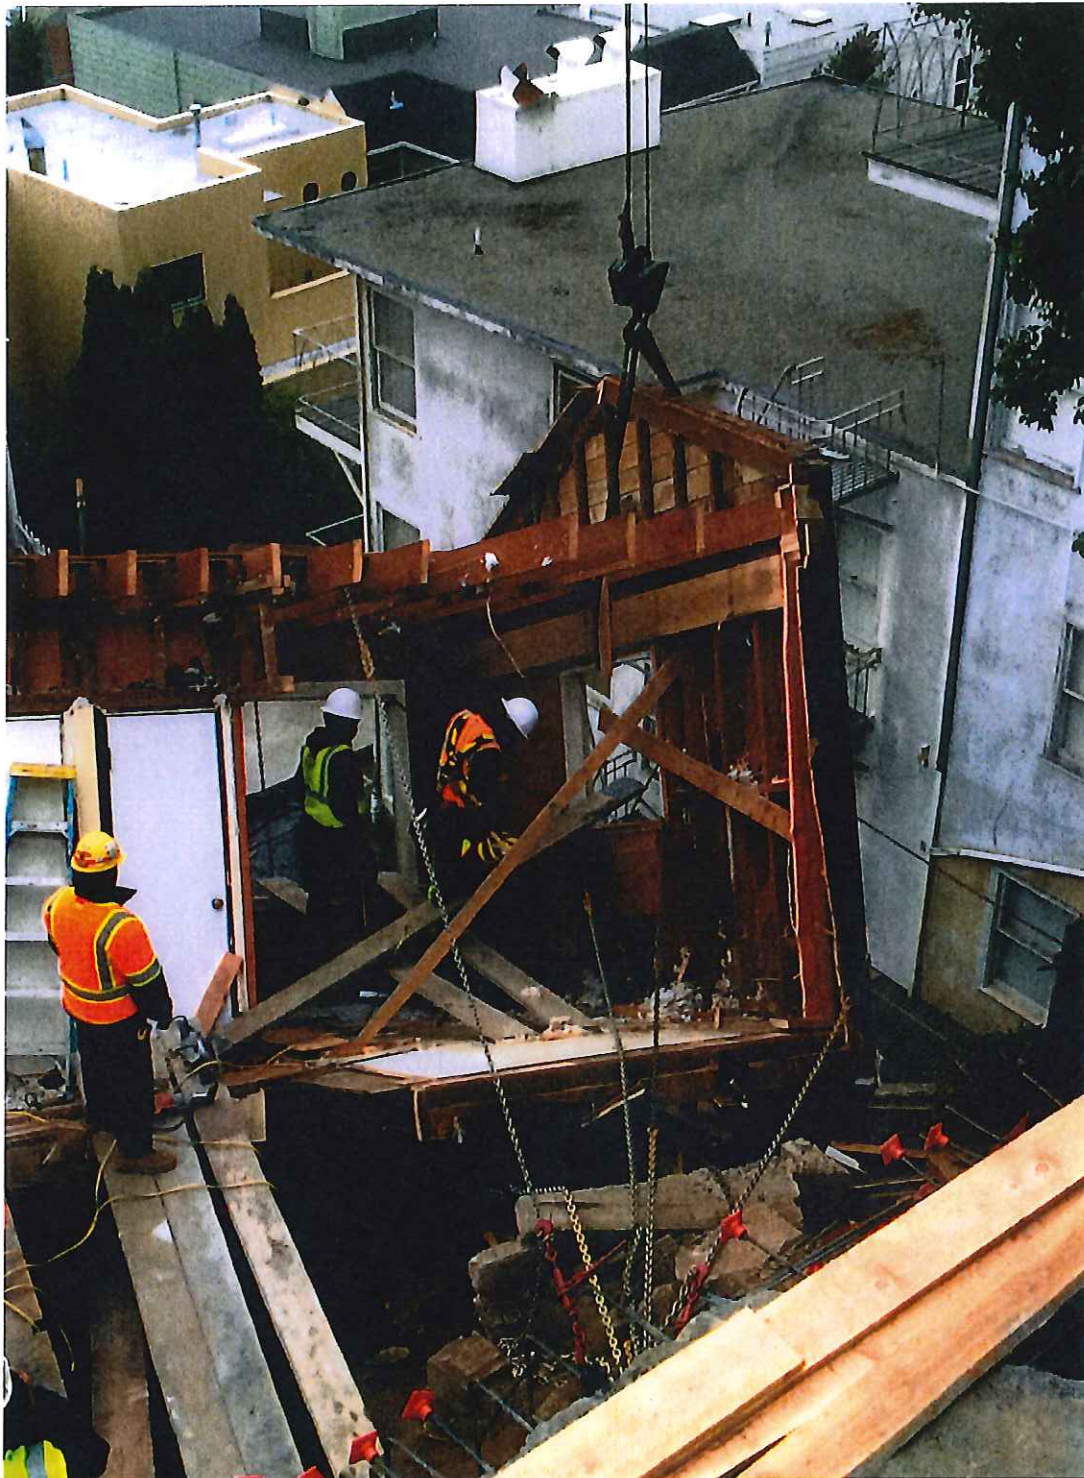
Figure 9: Removal and Retention of Exterior Walls

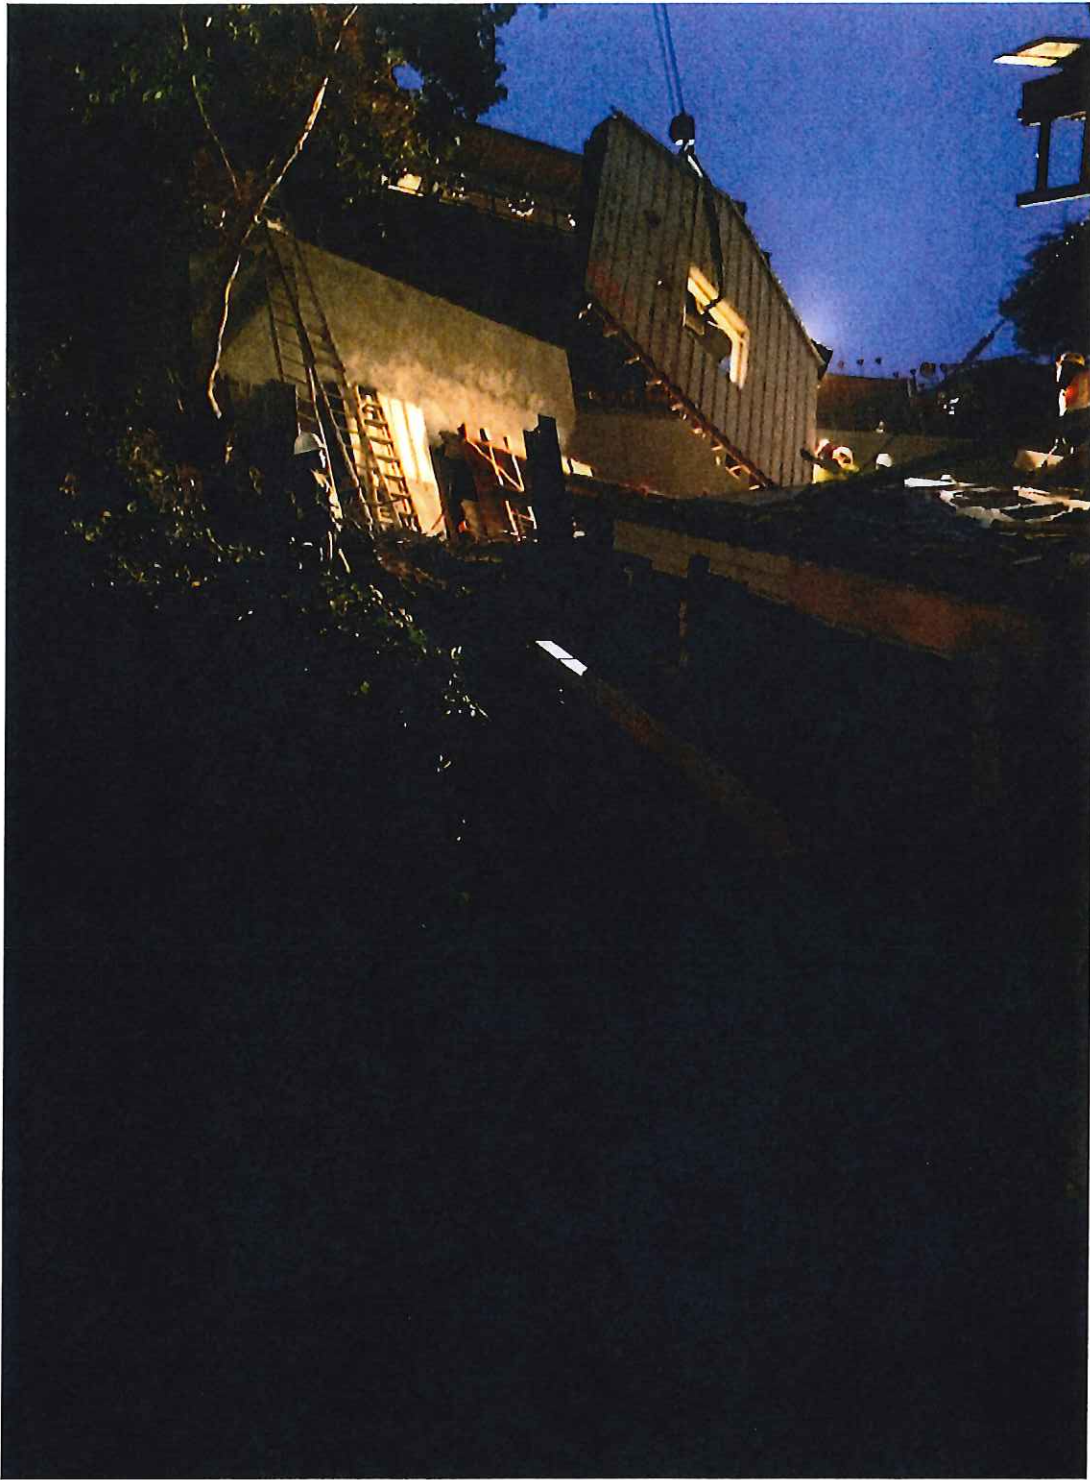
Figure 10: Removal and Retention of Exterior Walls

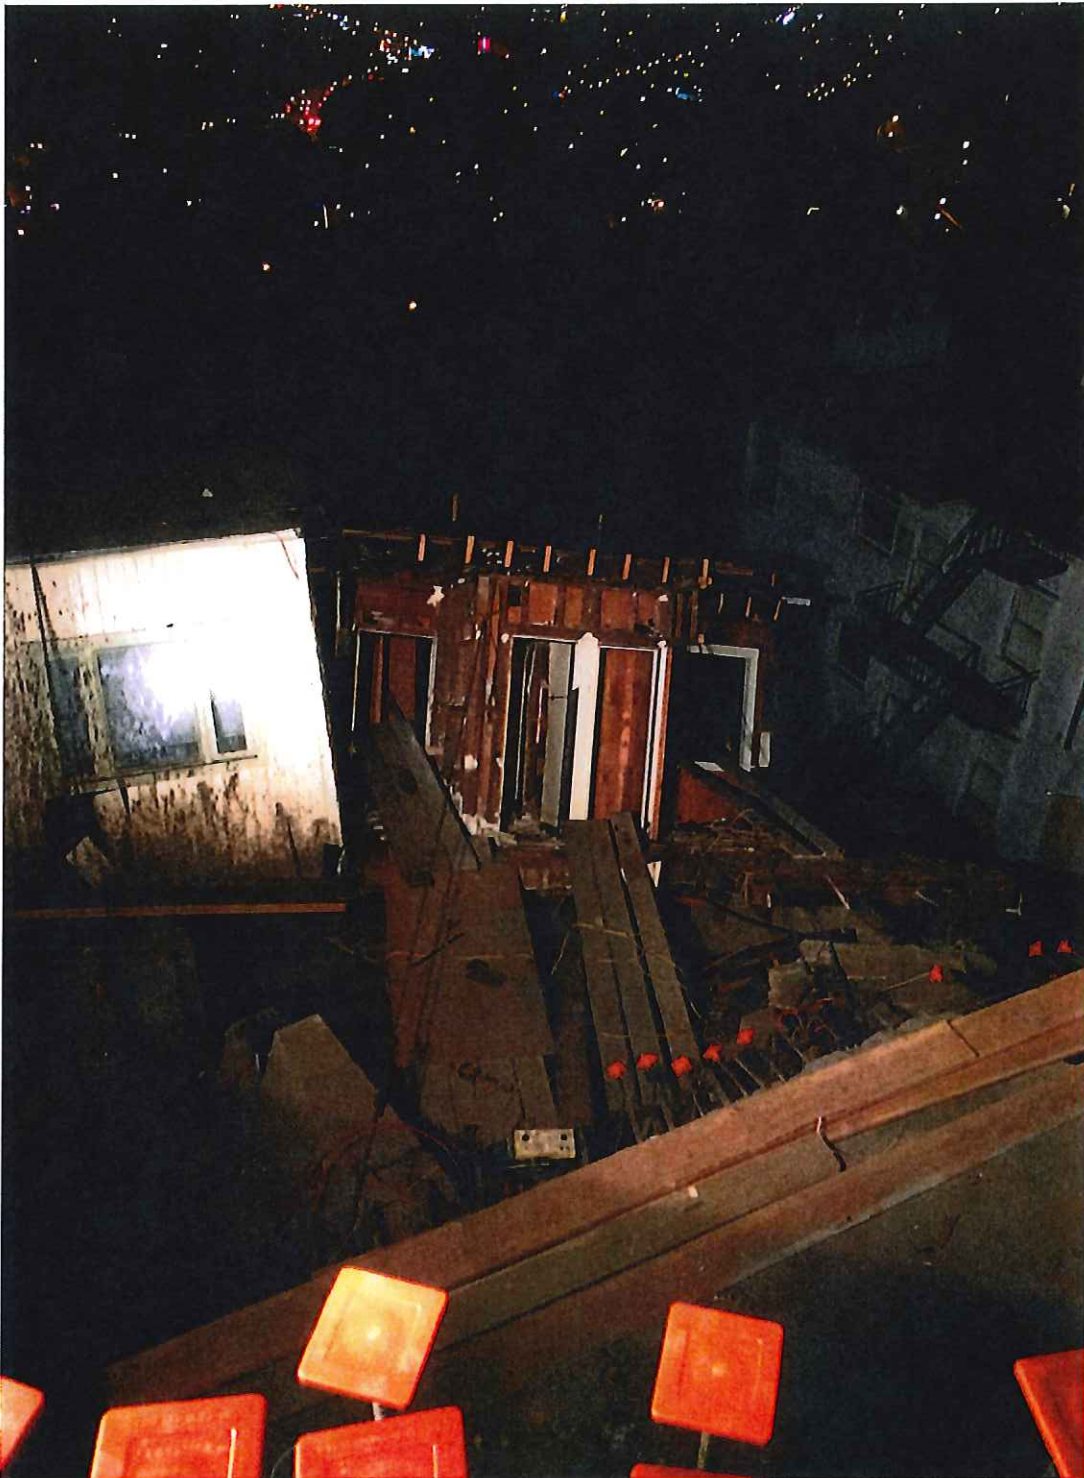
Figure 11: Removal and Retention of Exterior Walls

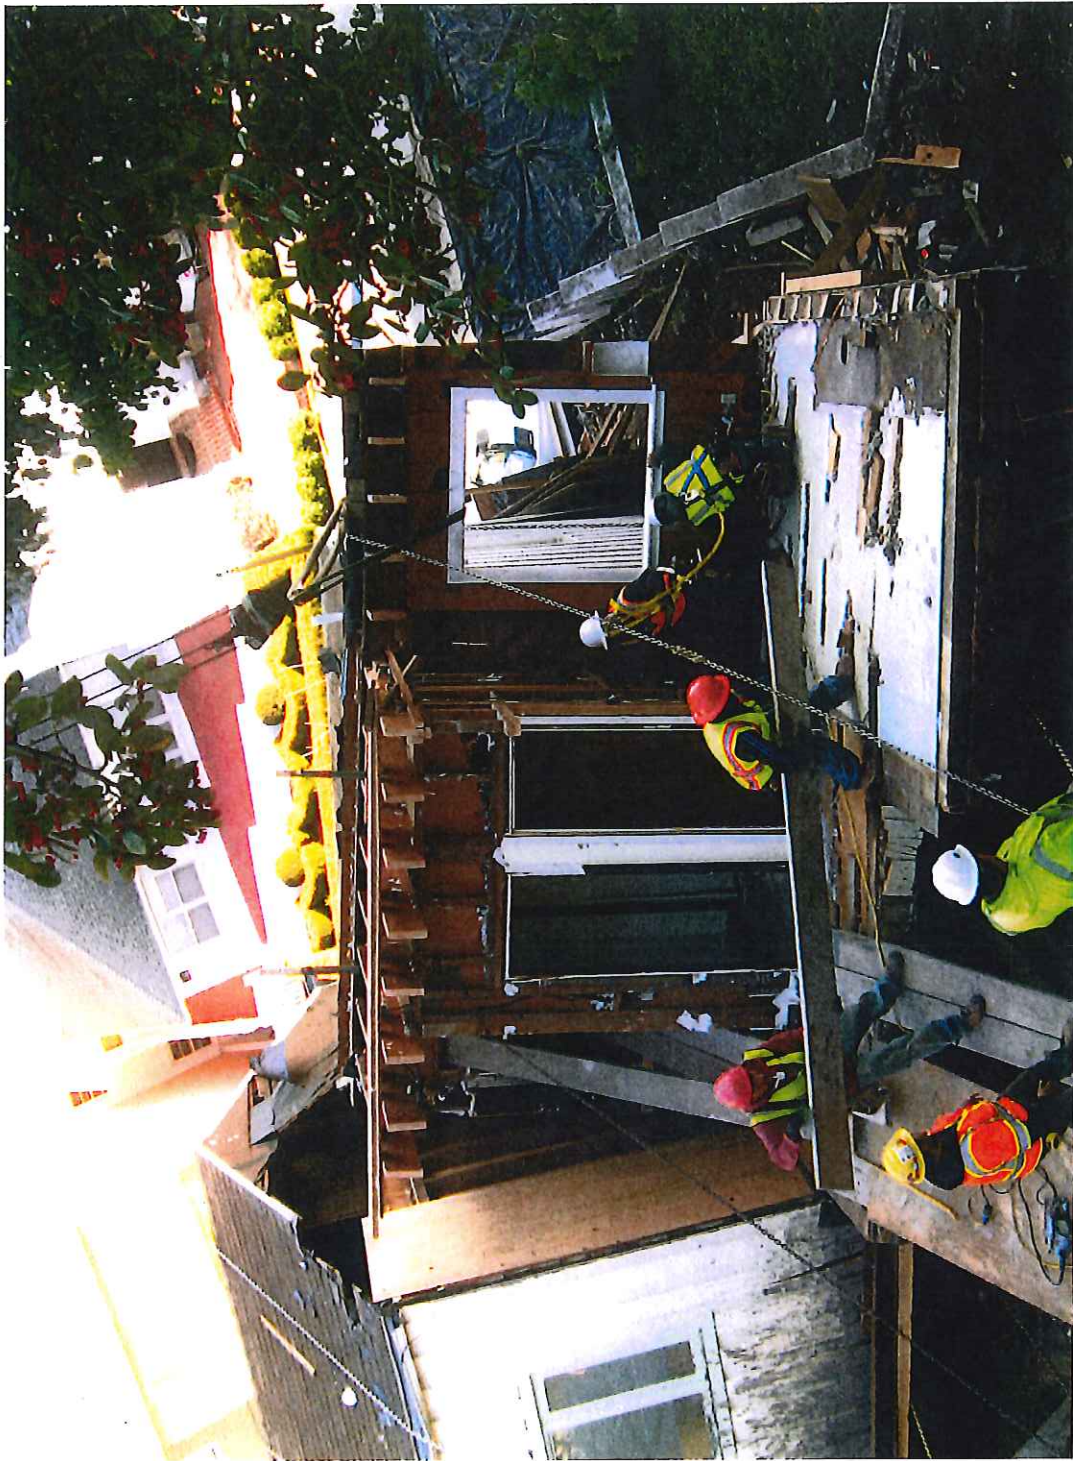
Figure 12: Removal and Retention of Exterior Walls

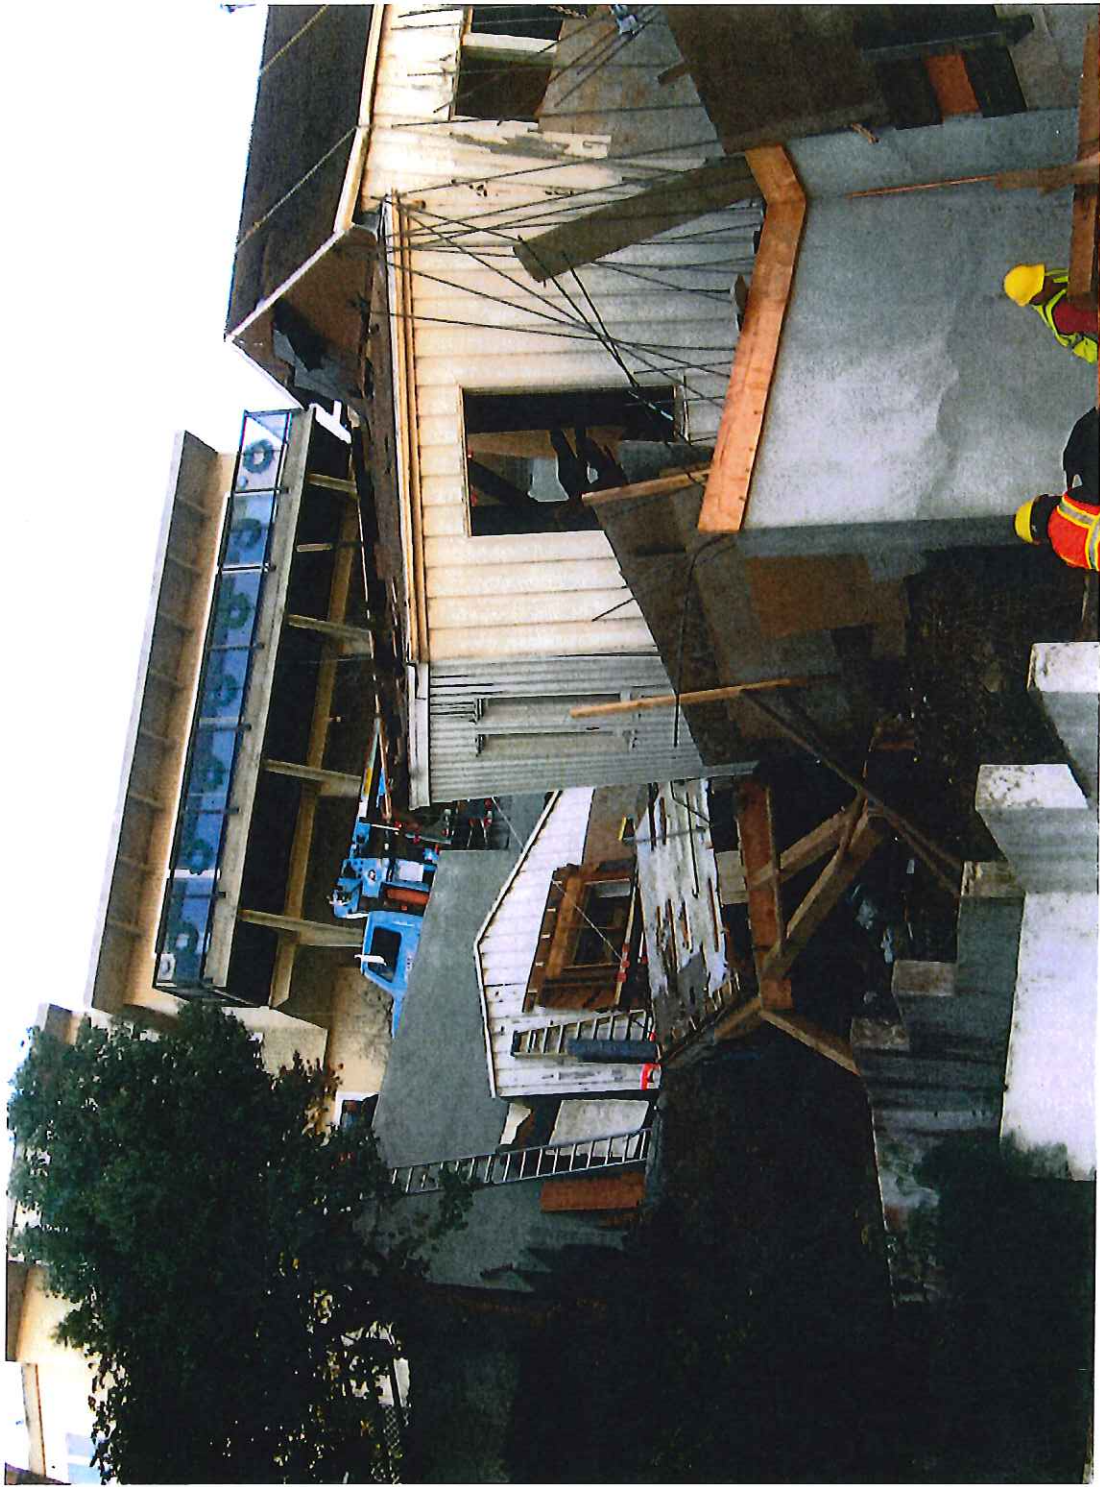
Figure 13: Removal and Retention of Exterior Walls
