Project Number: 19-009

Subject: 301 Mission Retrofit Supplemental Monitoring Report 067: Results as of August 16, 2022

Millennium Tower Perimeter Pile Upgrade: Instrumentation Monitoring Data  
City and County of San Francisco, California

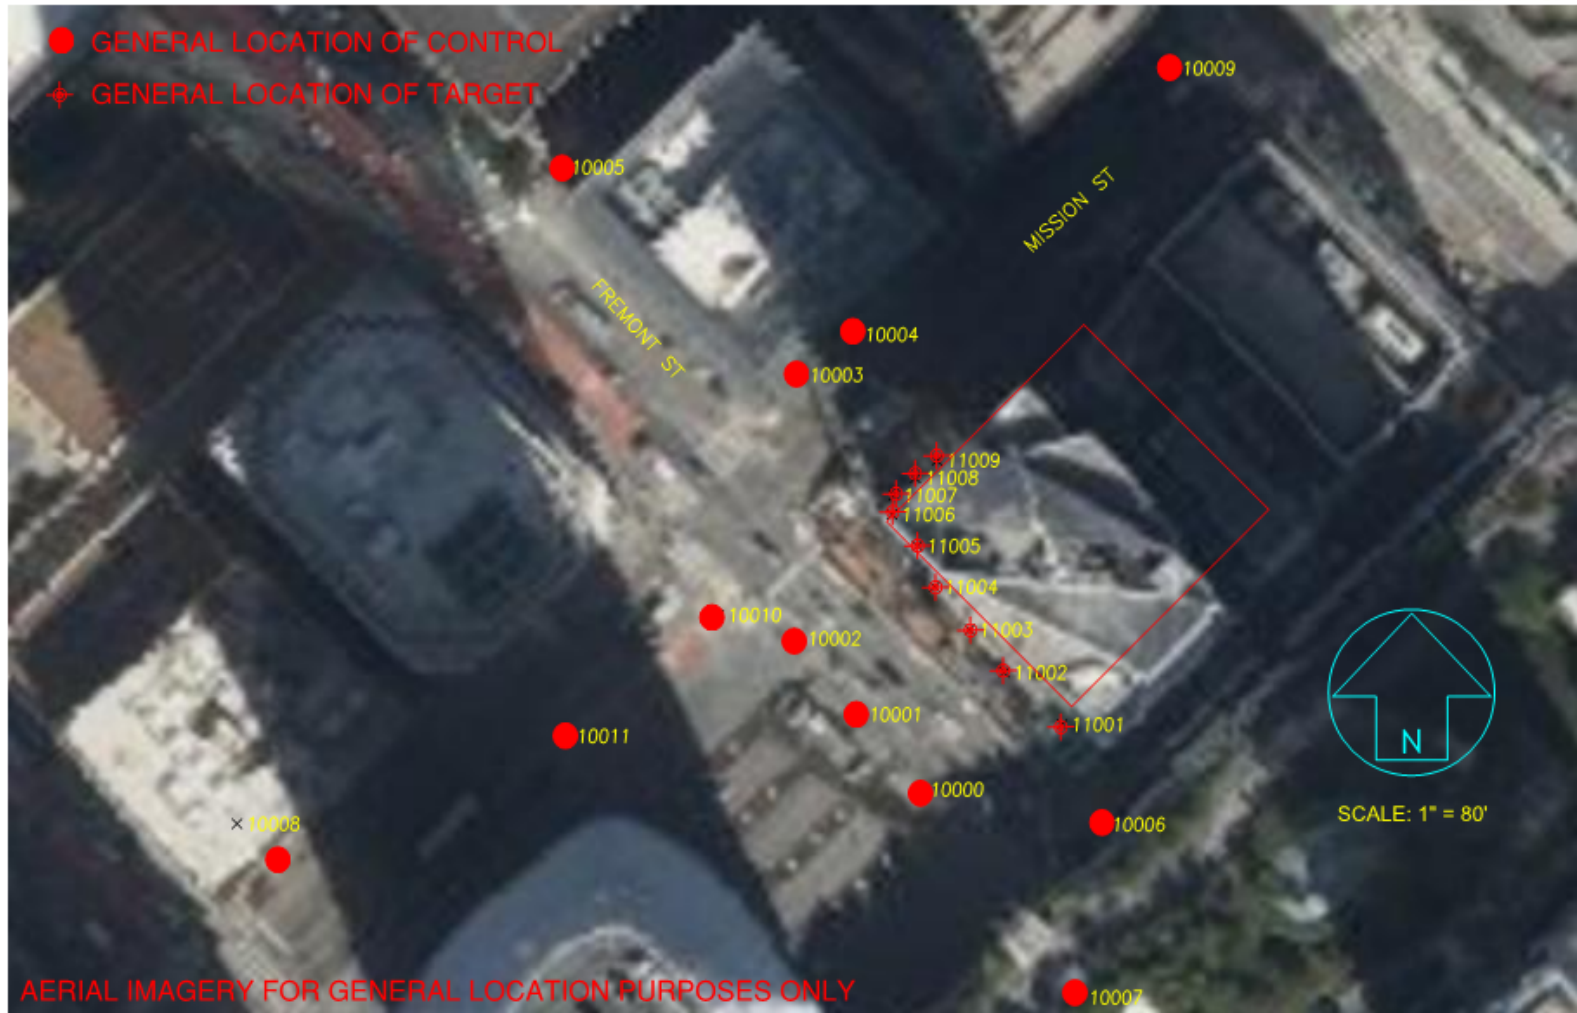
| Project No: 19-009.00 | Date: 5/3/2022 | Created By: NBW | Checked By: DGM | Figure No: <b>067S-01</b> |

Figure S-01 presents the locations of the survey prisms (including both control and target prisms) as referenced in later figures.

Figure S-01A – Instrument Location Map: Horizontal Survey Control and Target Points at First Level

INSTRUMENT LOCATION MAP  
HORIZONTAL SURVEY CONTROL AND TARGET POINTS AT FIRST LEVEL

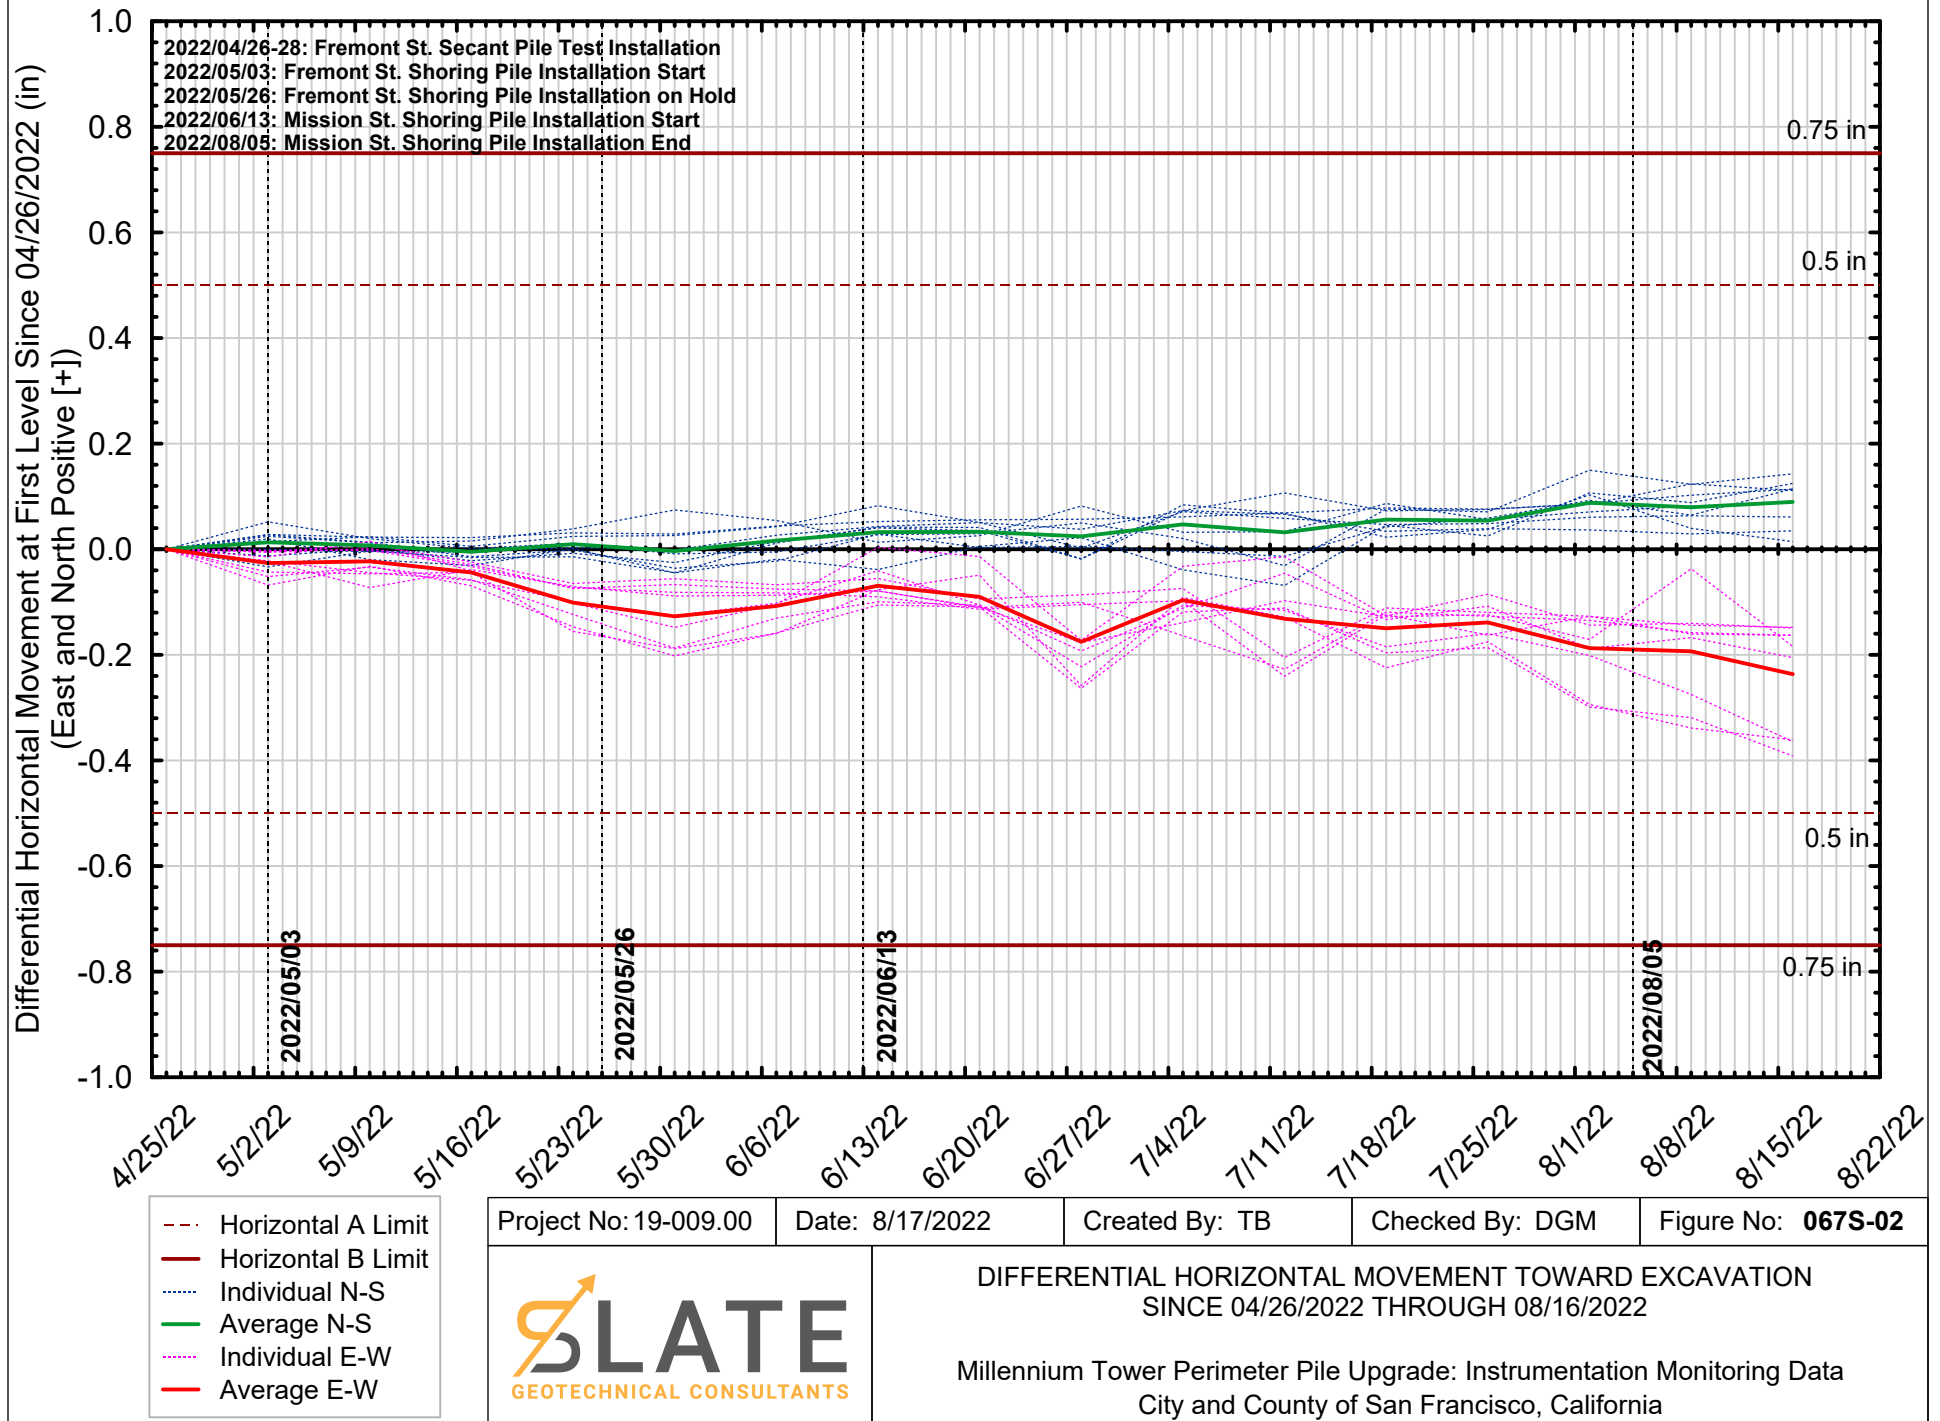
Figure S-02 presents the differential horizontal movement toward the excavation at survey prisms installed at approximately one floor level above grade on the exterior of the building, as well as the average in each of the project north-south and east-west direction, since April 26, 2022, through August 16, 2022. Limits established in the aforementioned letter are included for reference.

Figure S-02 – Differential Horizontal Movement Toward Excavation Since 04/26/2022 through 08/16/2022

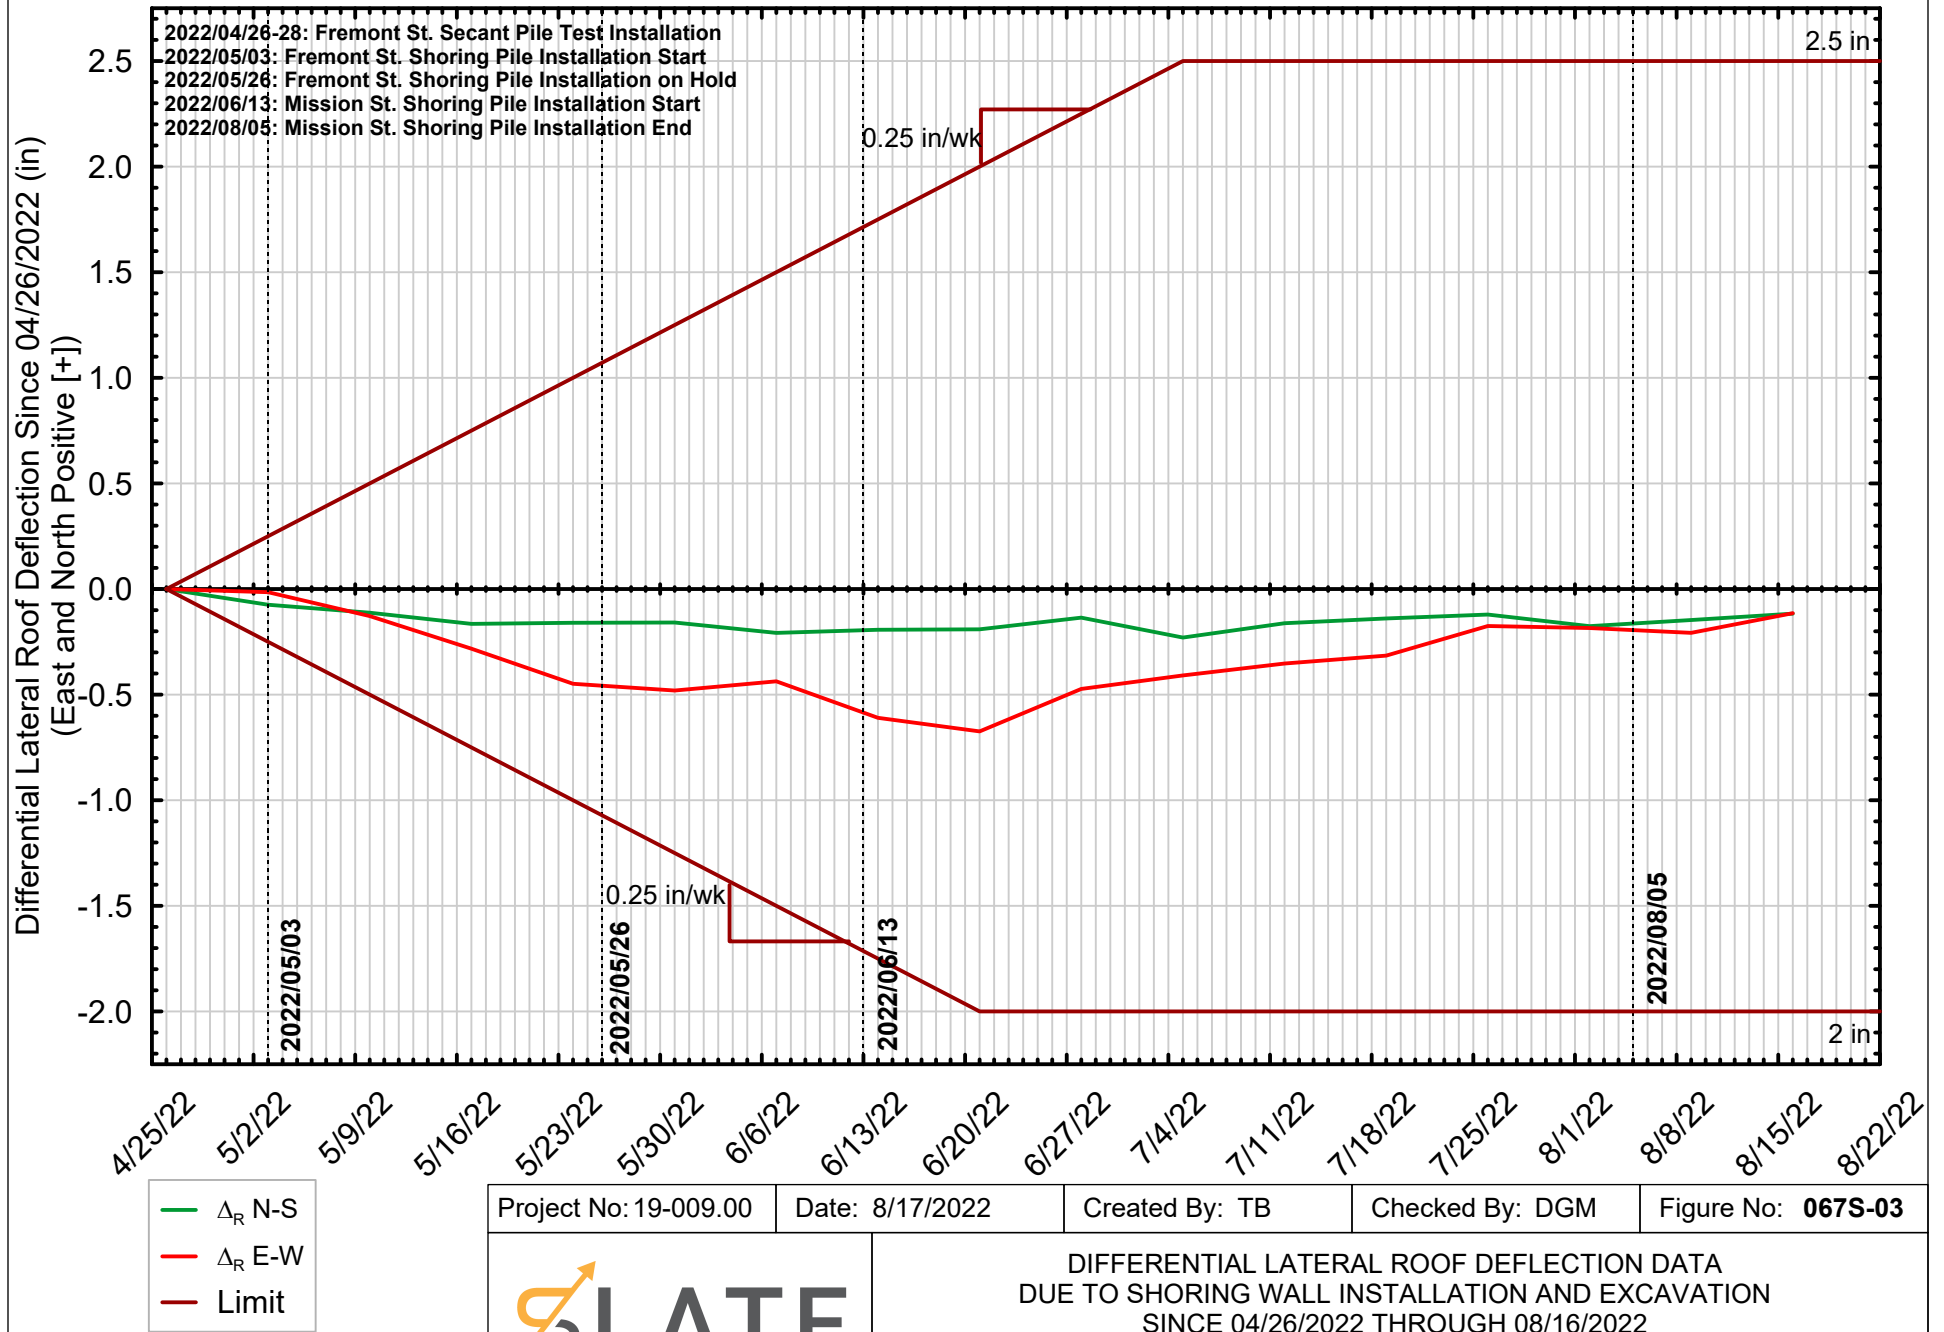
Figure No: **067S-03**

Figure S-03 presents differential lateral roof deflection data due to shoring wall installation and excavation since April 26, 2022, through August 16, 2022. Limits established in the aforementioned letter are included for reference. Note that differential lateral roof deflection due to shoring wall installation and excavation is calculated following the aforementioned letter as:

$$\Delta_R = \Delta_{R-prism} - \Delta_H - \alpha T$$

where:  $\Delta_R$  is the computed differential lateral roof deflection due to shoring wall installation and excavation;  
 $\Delta_{R-prism}$  is the differential lateral roof deflection obtained from prism data;  
 $\Delta_H$  is the average differential horizontal movement "at-grade";  
 $\alpha$  is the weekly lateral roof deflection rate (computed as described below); and,  
 $T$  is the number of weeks since initiation of shoring wall installation or excavation.

Figure S-03 – Differential Lateral Roof Deflection Data due to Shoring Wall Installation and Excavation since 04/26/2022 through 08/16/2022

DIFFERENTIAL LATERAL ROOF DEFLECTION DATA  
 DUE TO SHORING WALL INSTALLATION AND EXCAVATION  
 SINCE 04/26/2022 THROUGH 08/16/2022  
 Millennium Tower Perimeter Pile Upgrade: Instrumentation Monitoring Data  
 City and County of San Francisco, California

The time frame over which  $\alpha$  is computed changes depending on the phase of the work, as specified in the aforementioned letter. For the construction phase during which the shoring wall is installed (currently ongoing),  $\alpha$  is computed from the two months of monitoring conducted immediately prior to the shoring wall installation (i.e., monitoring data from February 22, 2022, through April 25, 2022). During the excavation phase (to occur in the future),  $\alpha$  will be readjusted to reflect the recorded lateral roof deflection rate in the two months immediately preceding the start of excavation (dates to be determined).

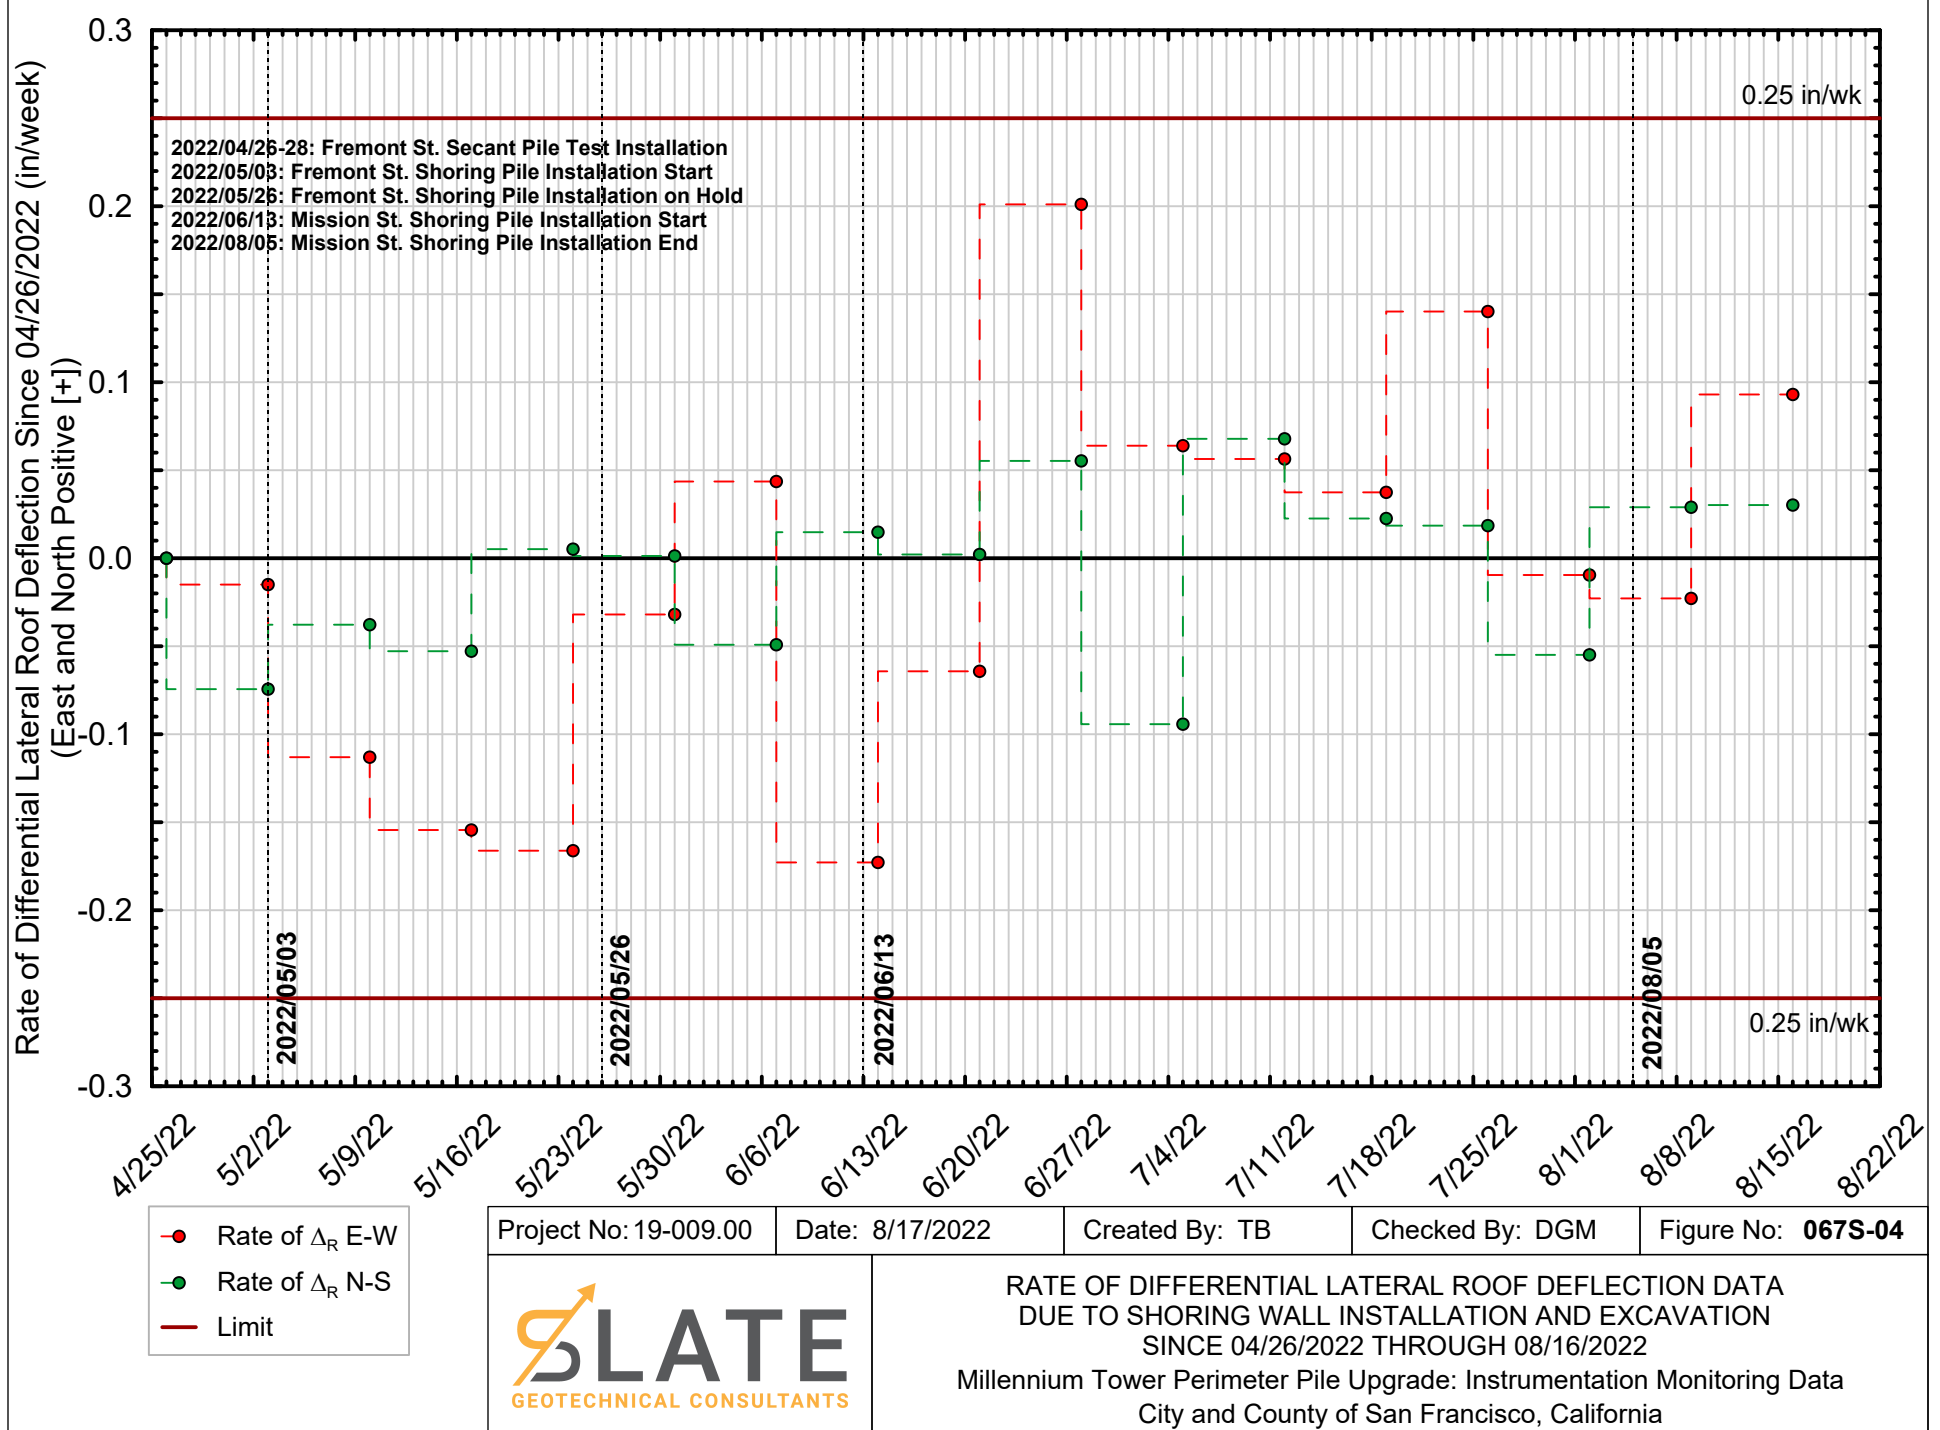
Figure S-04 presents rates of differential lateral roof deflection data due to shoring wall installation and excavation since April 26, 2022, through August 16, 2022. Limits established in the aforementioned letter are included for reference. Note that the rates are calculated as:

$$\frac{d\Delta_R}{dT} \approx \frac{\Delta_{R,t} - \Delta_{R,t-1}}{T_t - T_{t-1}}$$

where:  $t$  is an index representing the current instance in time; and  
 $t - 1$  is an index representing the previous instance in time.

Figure S-04 – Rate of Differential Lateral Roof Deflection Data due to Shoring Wall Installation and Excavation since 04/26/2022 through 08/16/2022
