Project Number: 19-009

Subject: 301 Mission Retrofit Supplemental Monitoring Report 073: Results as of September 28, 2022

Millennium Tower Perimeter Pile Upgrade: Instrumentation Monitoring Data
City and County of San Francisco, California

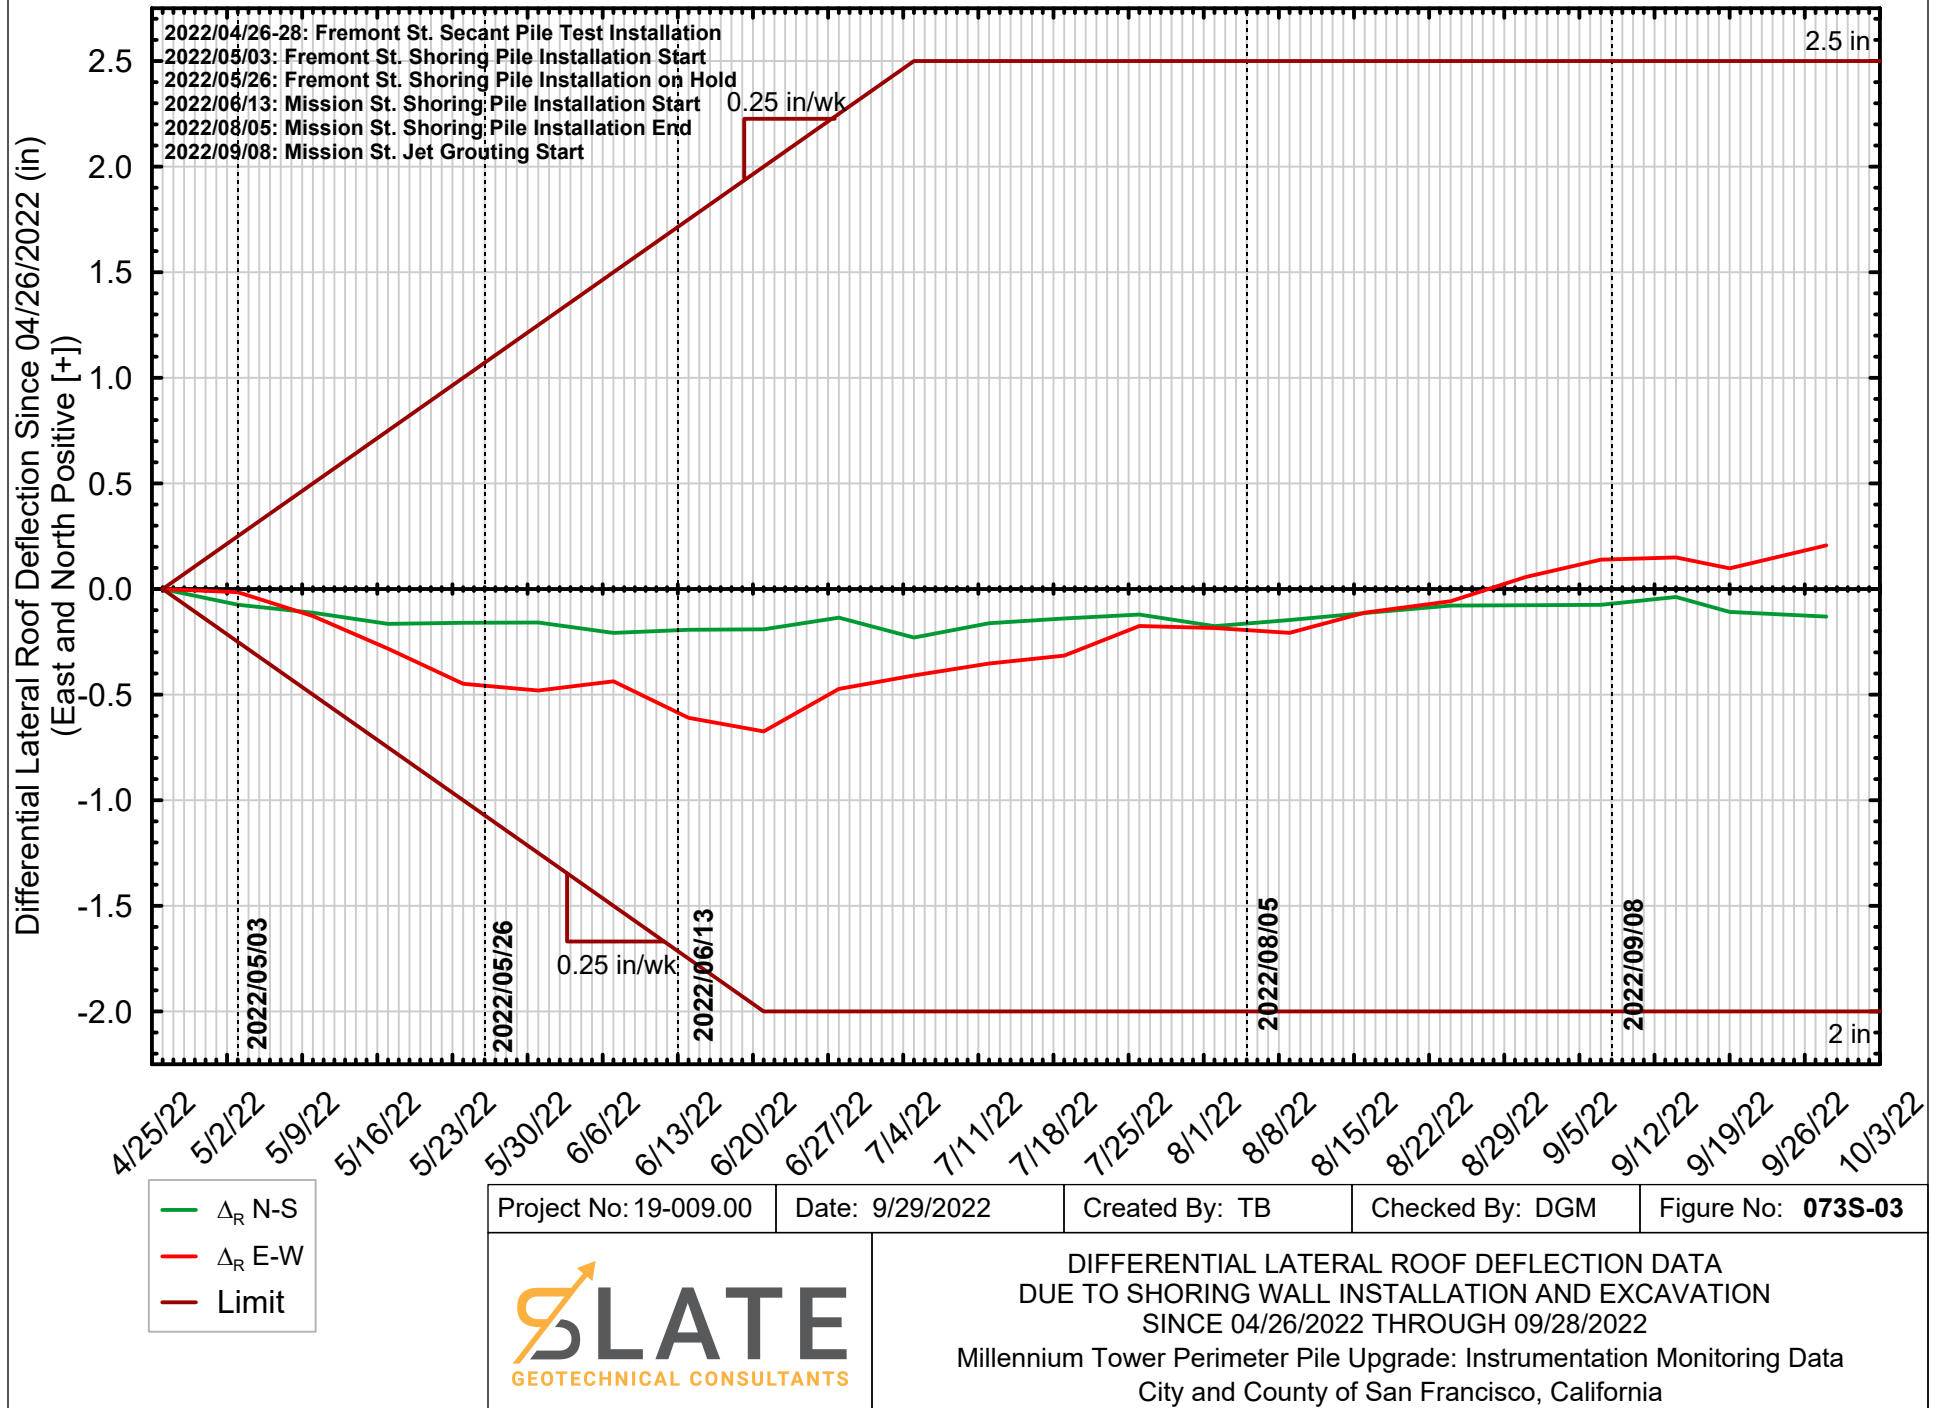
Figure S-03 presents differential lateral roof deflection data due to shoring wall installation and excavation since April 26, 2022, through September 28, 2022. Limits established in the aforementioned letter are included for reference. Note that differential lateral roof deflection due to shoring wall installation and excavation is calculated following the aforementioned letter as:

Figure S-03 – Differential Lateral Roof Deflection Data due to Shoring Wall Installation and Excavation since 04/26/2022 through 09/28/2022

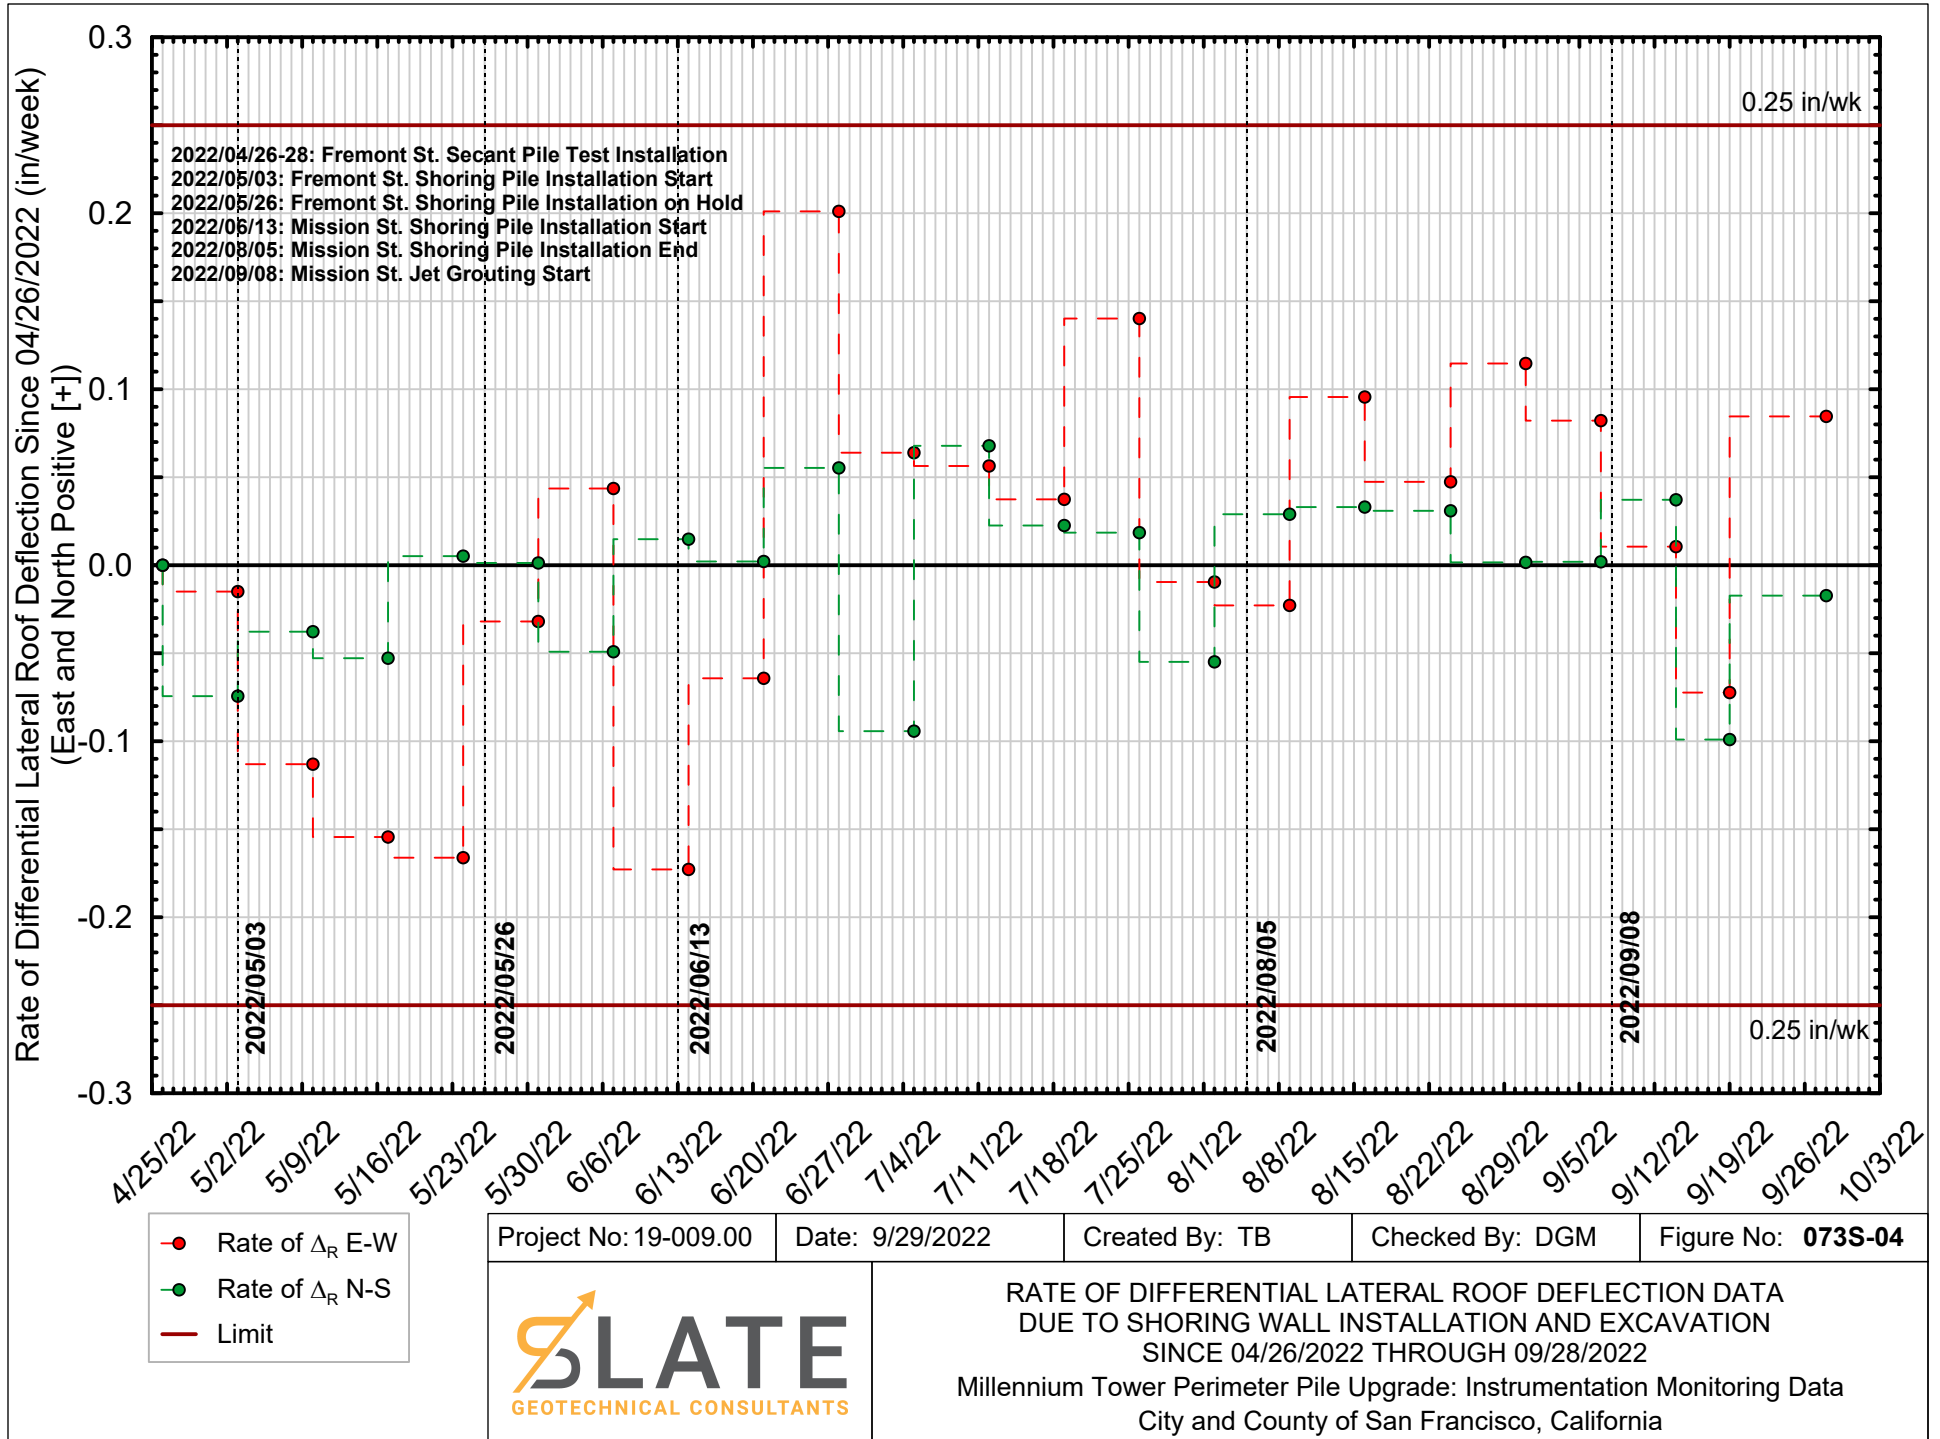
Figure S-04 presents rates of differential lateral roof deflection data due to shoring wall installation and excavation since April 26, 2022, through September 28, 2022. Limits established in the aforementioned letter are included for reference. Note that the rates are calculated as:

Figure S-04 – Rate of Differential Lateral Roof Deflection Data due to Shoring Wall Installation and Excavation since 04/26/2022 through 09/28/2022
