Project Number: 19-009

Subject: 301 Mission Retrofit Supplemental Monitoring Report 078: Results as of October 31, 2022

Millennium Tower Perimeter Pile Upgrade: Instrumentation Monitoring Data
City and County of San Francisco, California

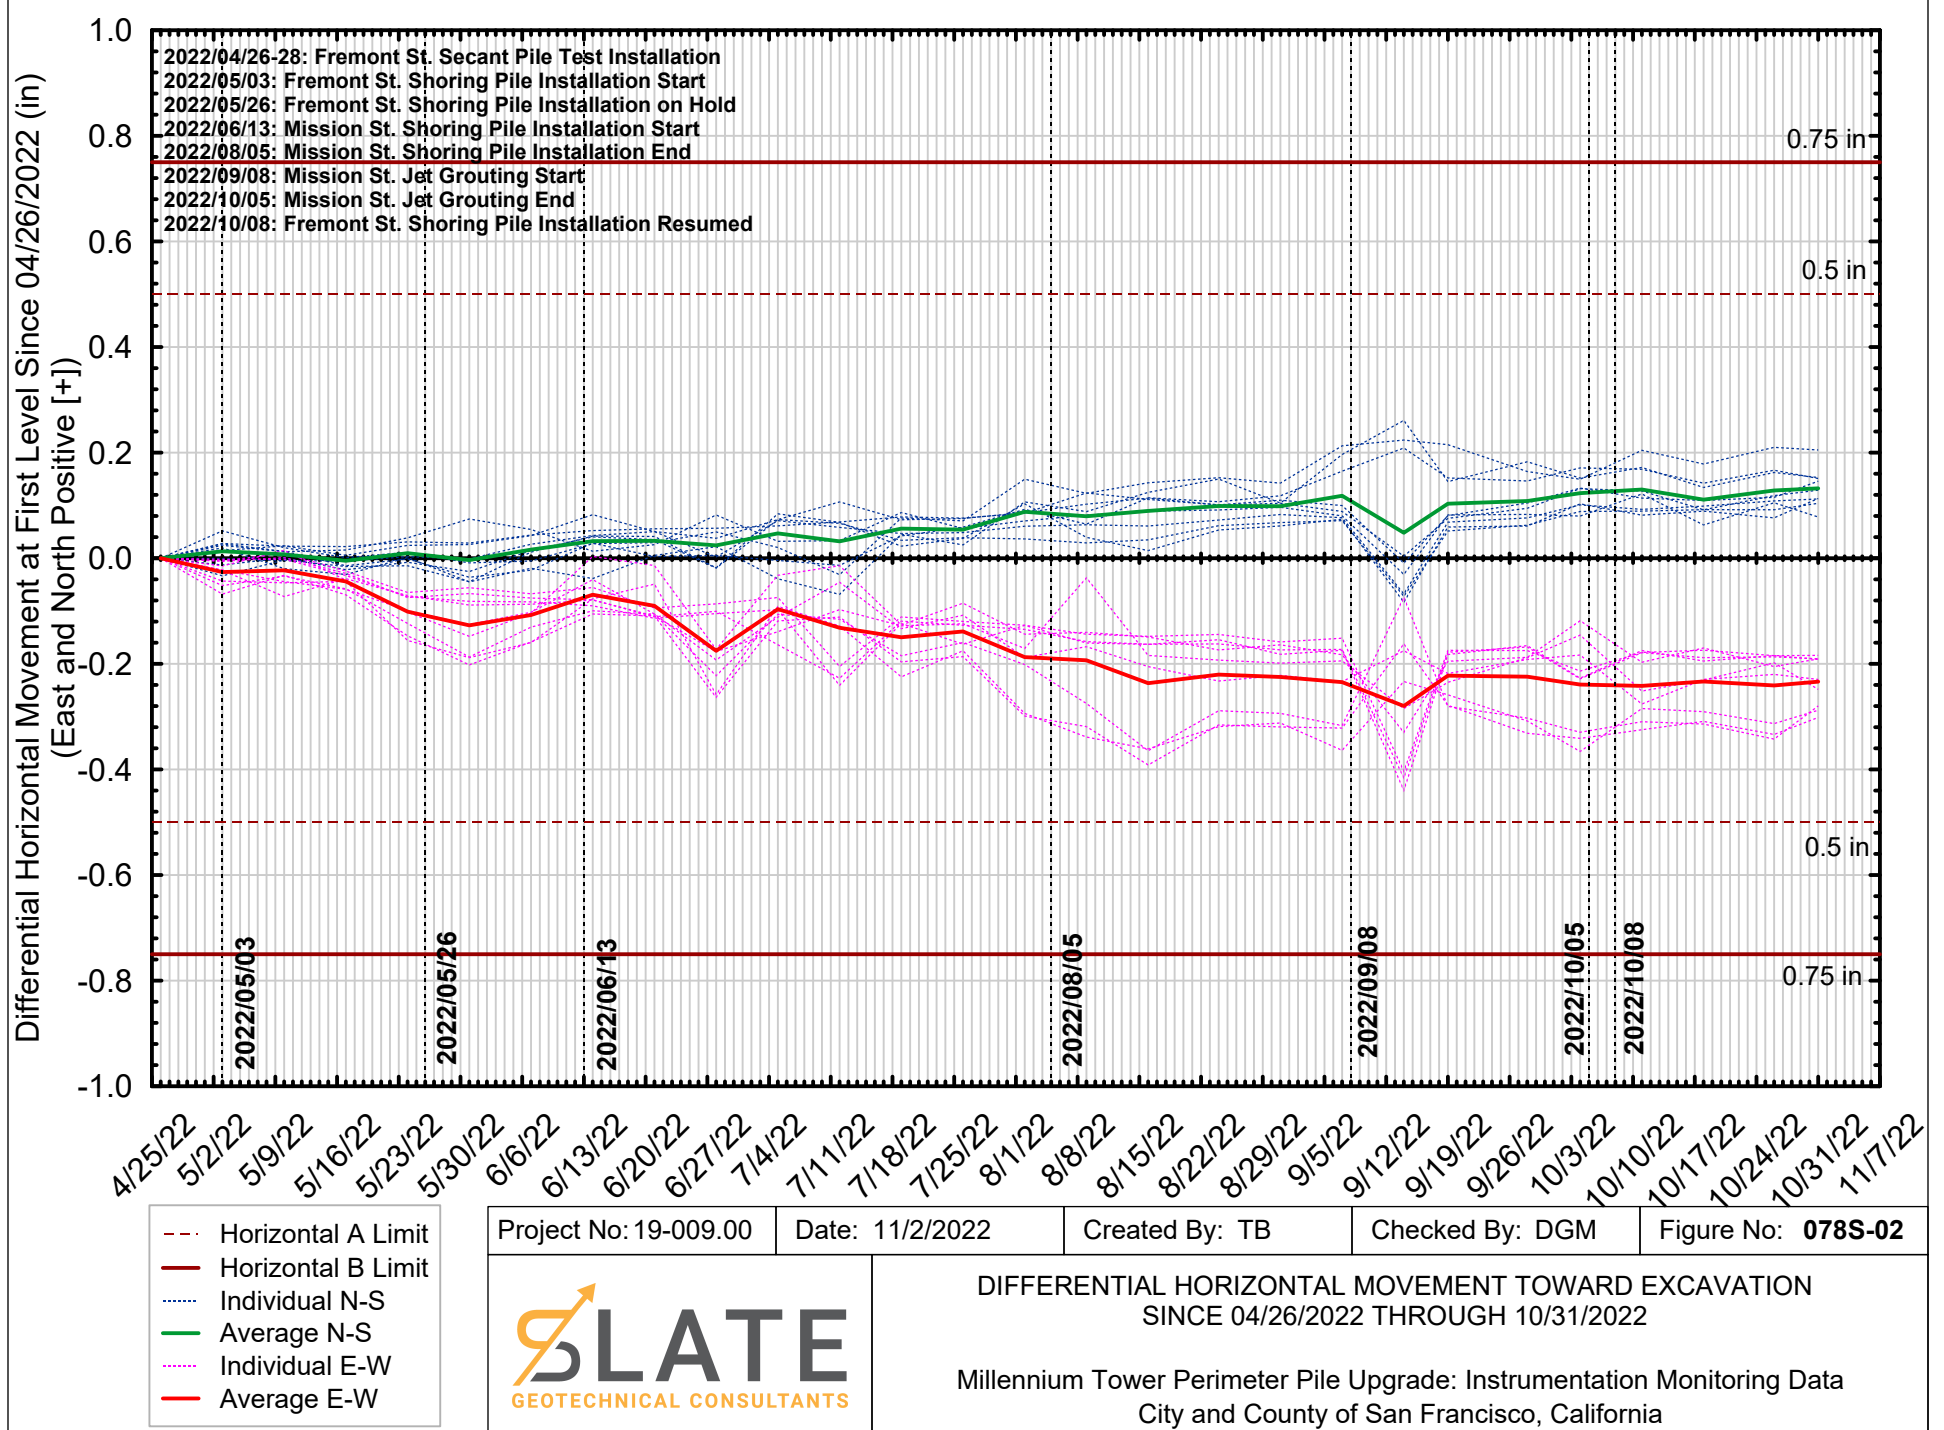
Figure S-02 – Differential Horizontal Movement Toward Excavation Since 04/26/2022 through 10/31/2022

Figure S-02 presents the differential horizontal movement toward the excavation at survey prisms installed at approximately one floor level above grade on the exterior of the building, as well as the average in each of the project north-south and east-west direction, since April 26, 2022, through October 31, 2022. Limits established in the aforementioned letter are included for reference.

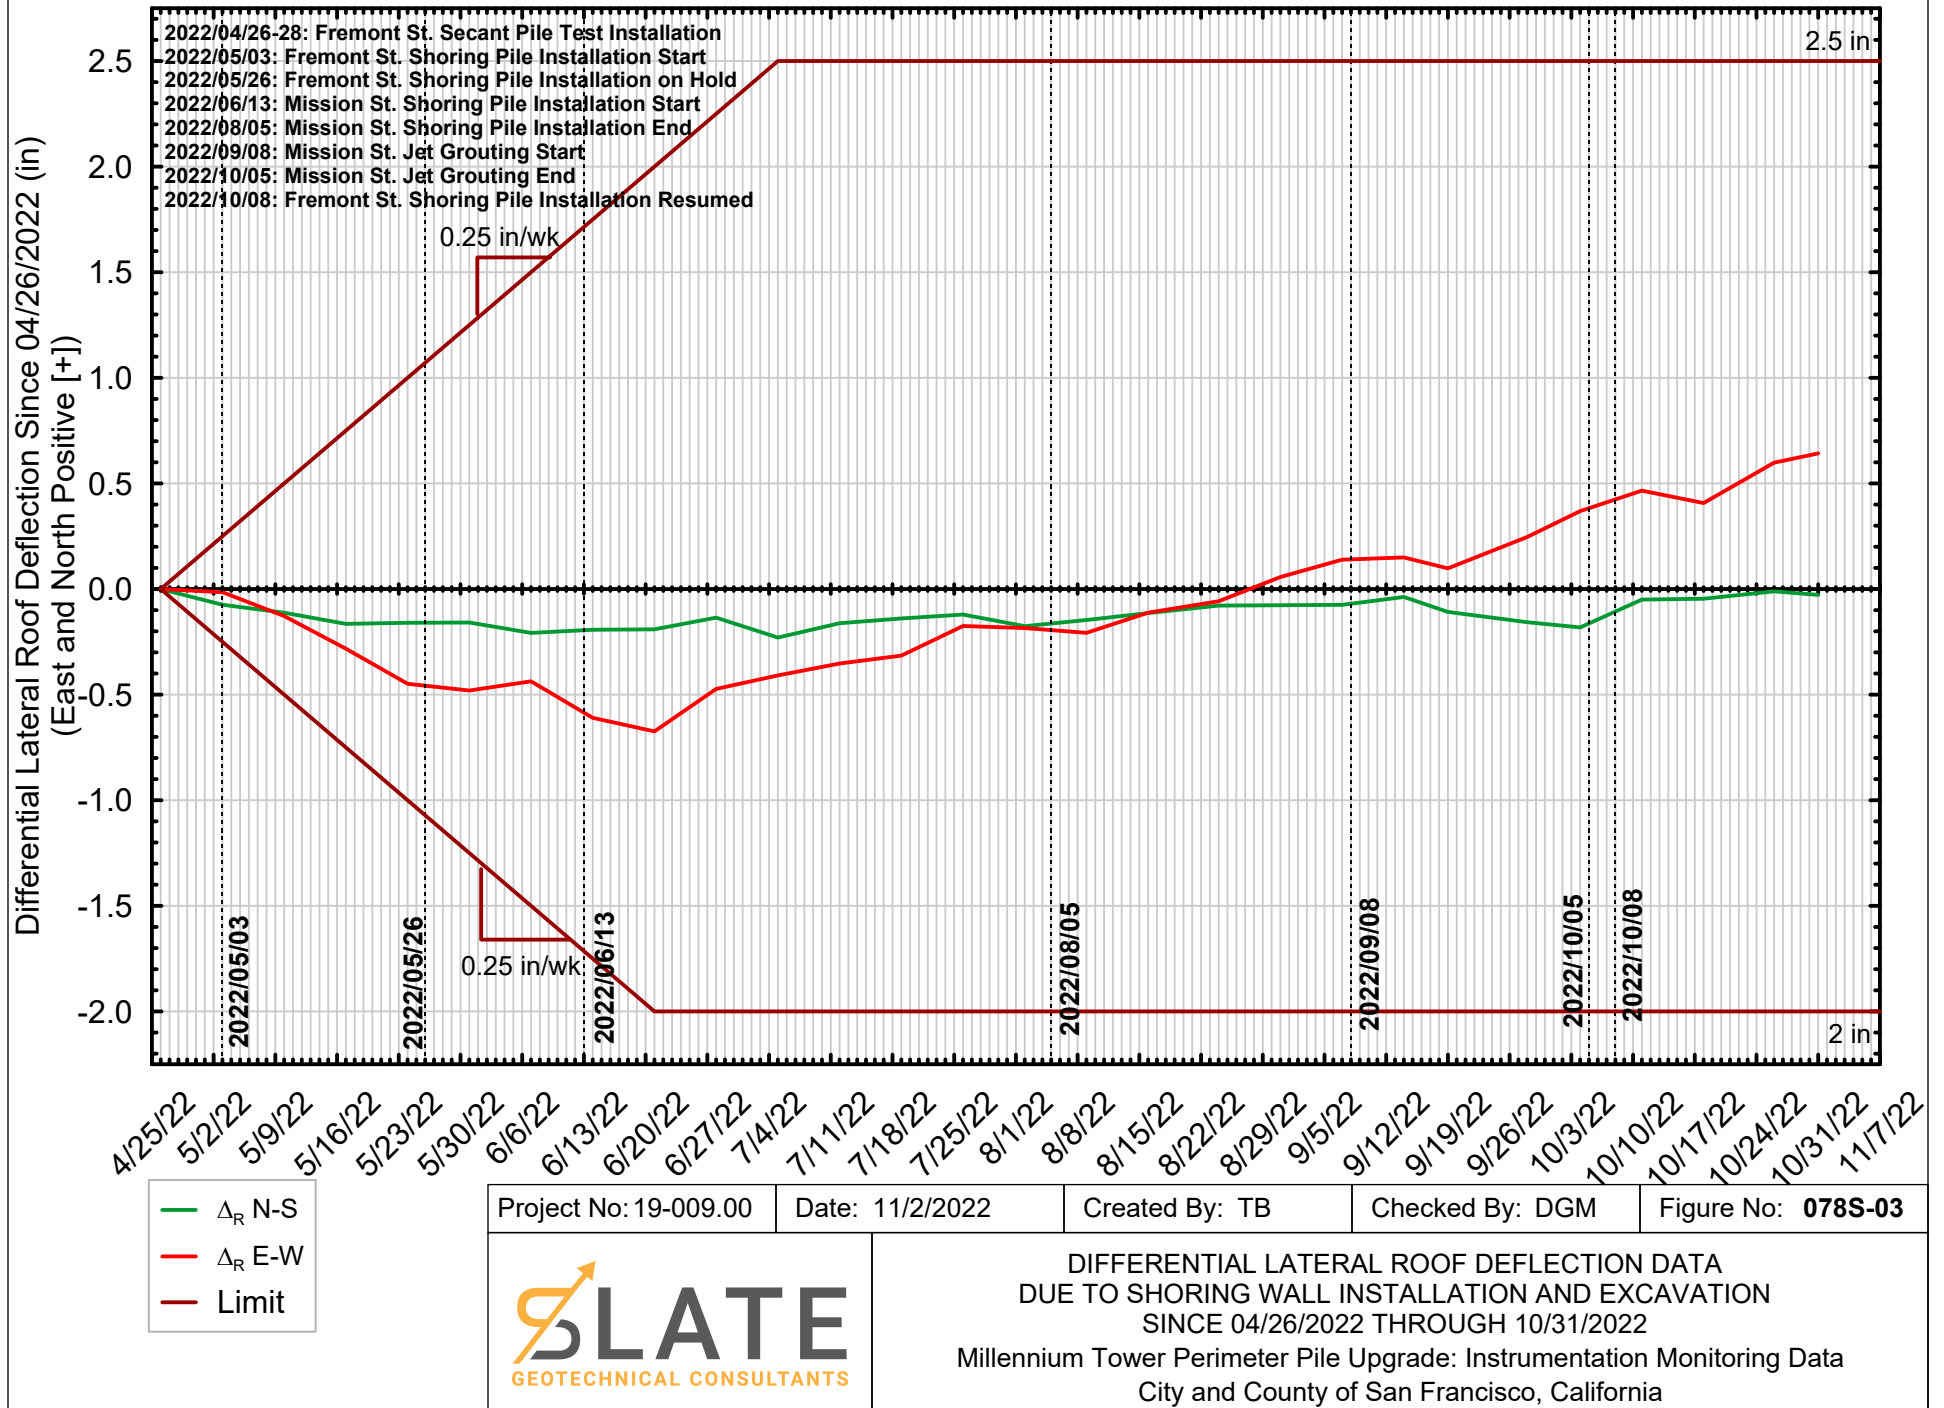
Figure S-03 – Differential Lateral Roof Deflection Data due to Shoring Wall Installation and Excavation since 04/26/2022 through 10/31/2022

Figure S-03 presents differential lateral roof deflection data due to shoring wall installation and excavation since April 26, 2022, through October 31, 2022. Limits established in the aforementioned letter are included for reference. Note that differential lateral roof deflection due to shoring wall installation and excavation is calculated following the aforementioned letter as:

$$\Delta_R = \Delta_{R-prism} - \Delta_H - \alpha T$$

where: Δ_R is the computed differential lateral roof deflection due to shoring wall installation and excavation;
 $\Delta_{R-prism}$ is the differential lateral roof deflection obtained from prism data;
 Δ_H is the average differential horizontal movement "at-grade";
 α is the weekly lateral roof deflection rate (computed as described below); and,
 T is the number of weeks since initiation of shoring wall installation or excavation.

The time frame over which α is computed changes depending on the phase of the work, as specified in the aforementioned letter. For the construction phase during which the shoring wall is installed (currently ongoing), α is computed from the two months of monitoring conducted immediately prior to the shoring wall installation (i.e., monitoring data from February 22, 2022, through April 25, 2022). During the excavation phase (to occur in the future), α will be readjusted to reflect the recorded lateral roof deflection rate in the two months immediately preceding the start of excavation (dates to be determined).

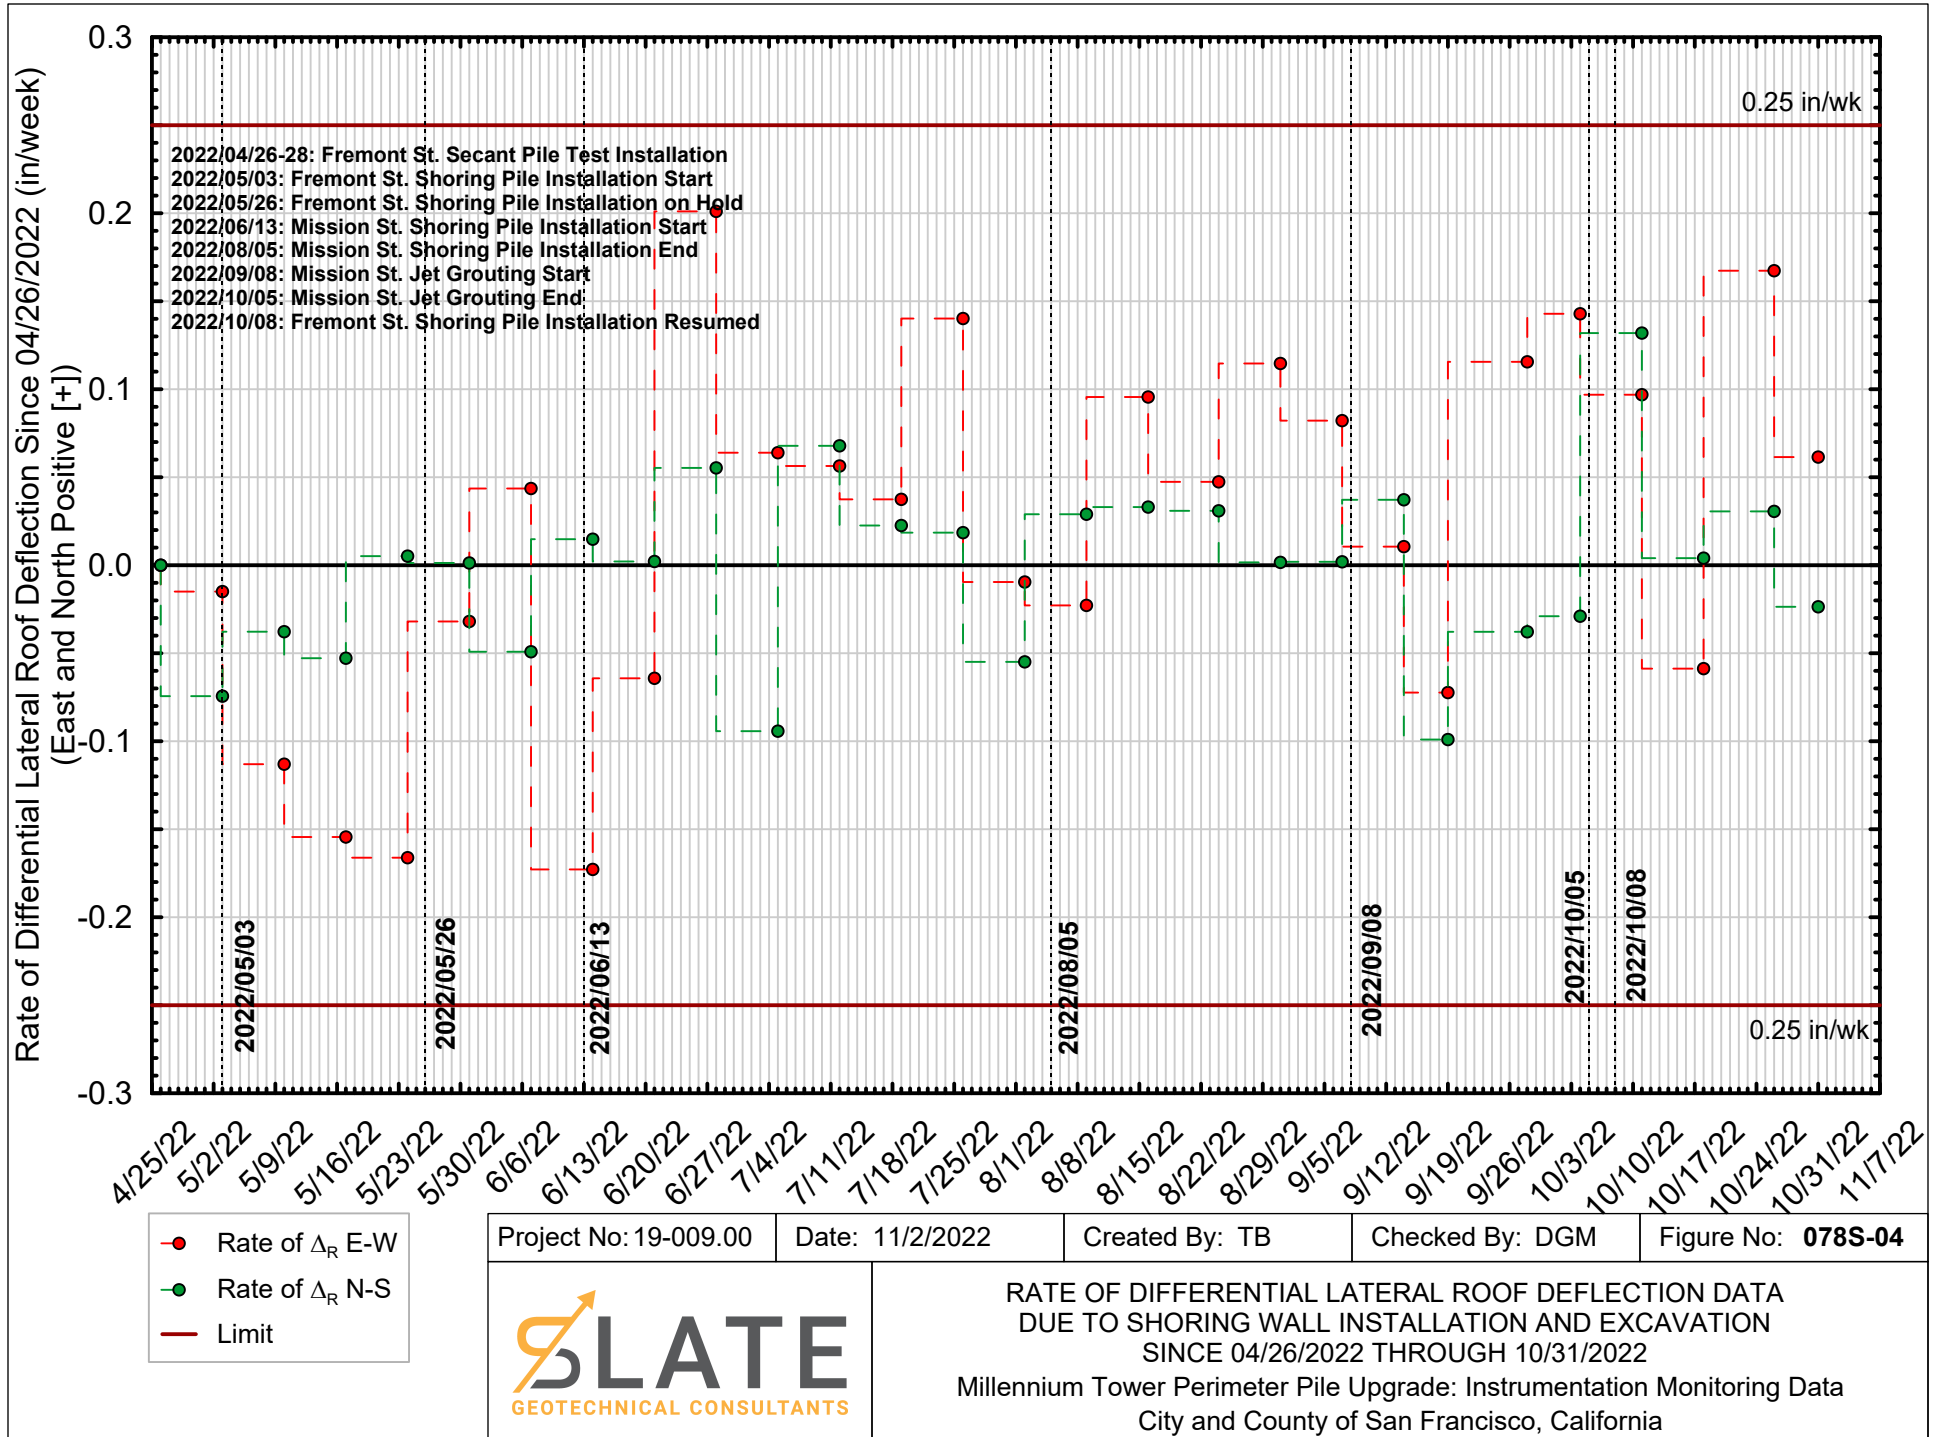
Figure S-04 – Rate of Differential Lateral Roof Deflection Data due to Shoring Wall Installation and Excavation since 04/26/2022 through 10/31/2022

Figure S-04 presents rates of differential lateral roof deflection data due to shoring wall installation and excavation since April 26, 2022, through October 31, 2022. Limits established in the aforementioned letter are included for reference. Note that the rates are calculated as:

$$\frac{d\Delta_R}{dT} \approx \frac{\Delta_{R,t} - \Delta_{R,t-1}}{T_t - T_{t-1}}$$

where: t is an index representing the current instance in time; and
 $t - 1$ is an index representing the previous instance in time.
