# **Investigation and Mitigation Report on Incident Occurring at**

**125 CROWN TERRACE**

**December 16, 2013**

**Tom C. Hui, S.E., C.B.O.**

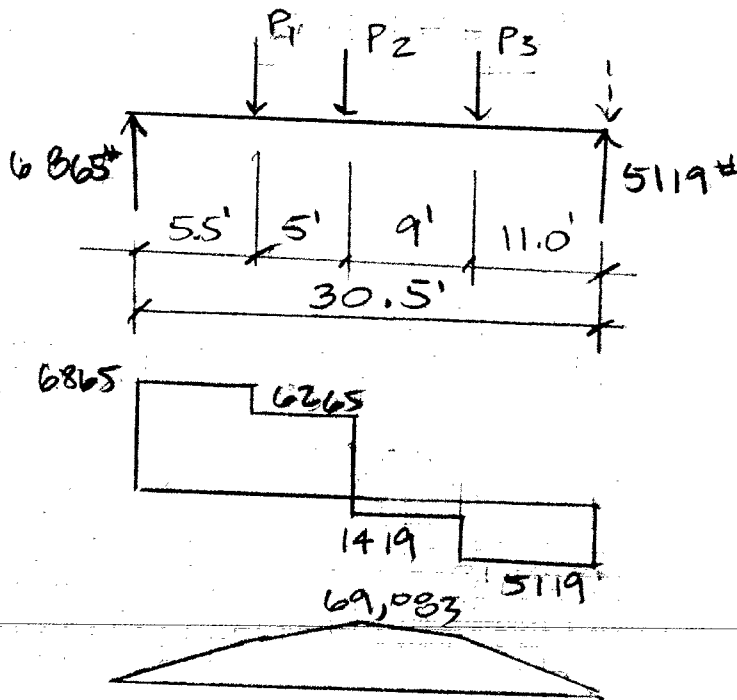
## LOAD TO BEAM

$$P_1 = \left(\frac{4'}{2}\right)(8')(9.0 + 19.1) + \left(8 + \frac{4 \times 4}{2}\right)(12.6) = 600\#$$

$$P_2 = P_1 + \left(\frac{10'}{2}\right)\left(\frac{26}{2} + 8\right)(3 + 9) + \left(\frac{26}{2} + 8\right)\left(\frac{22.5}{2}\right)(19.1) + \left(\frac{26}{2}\right)(12.6)8' = 7684\#$$

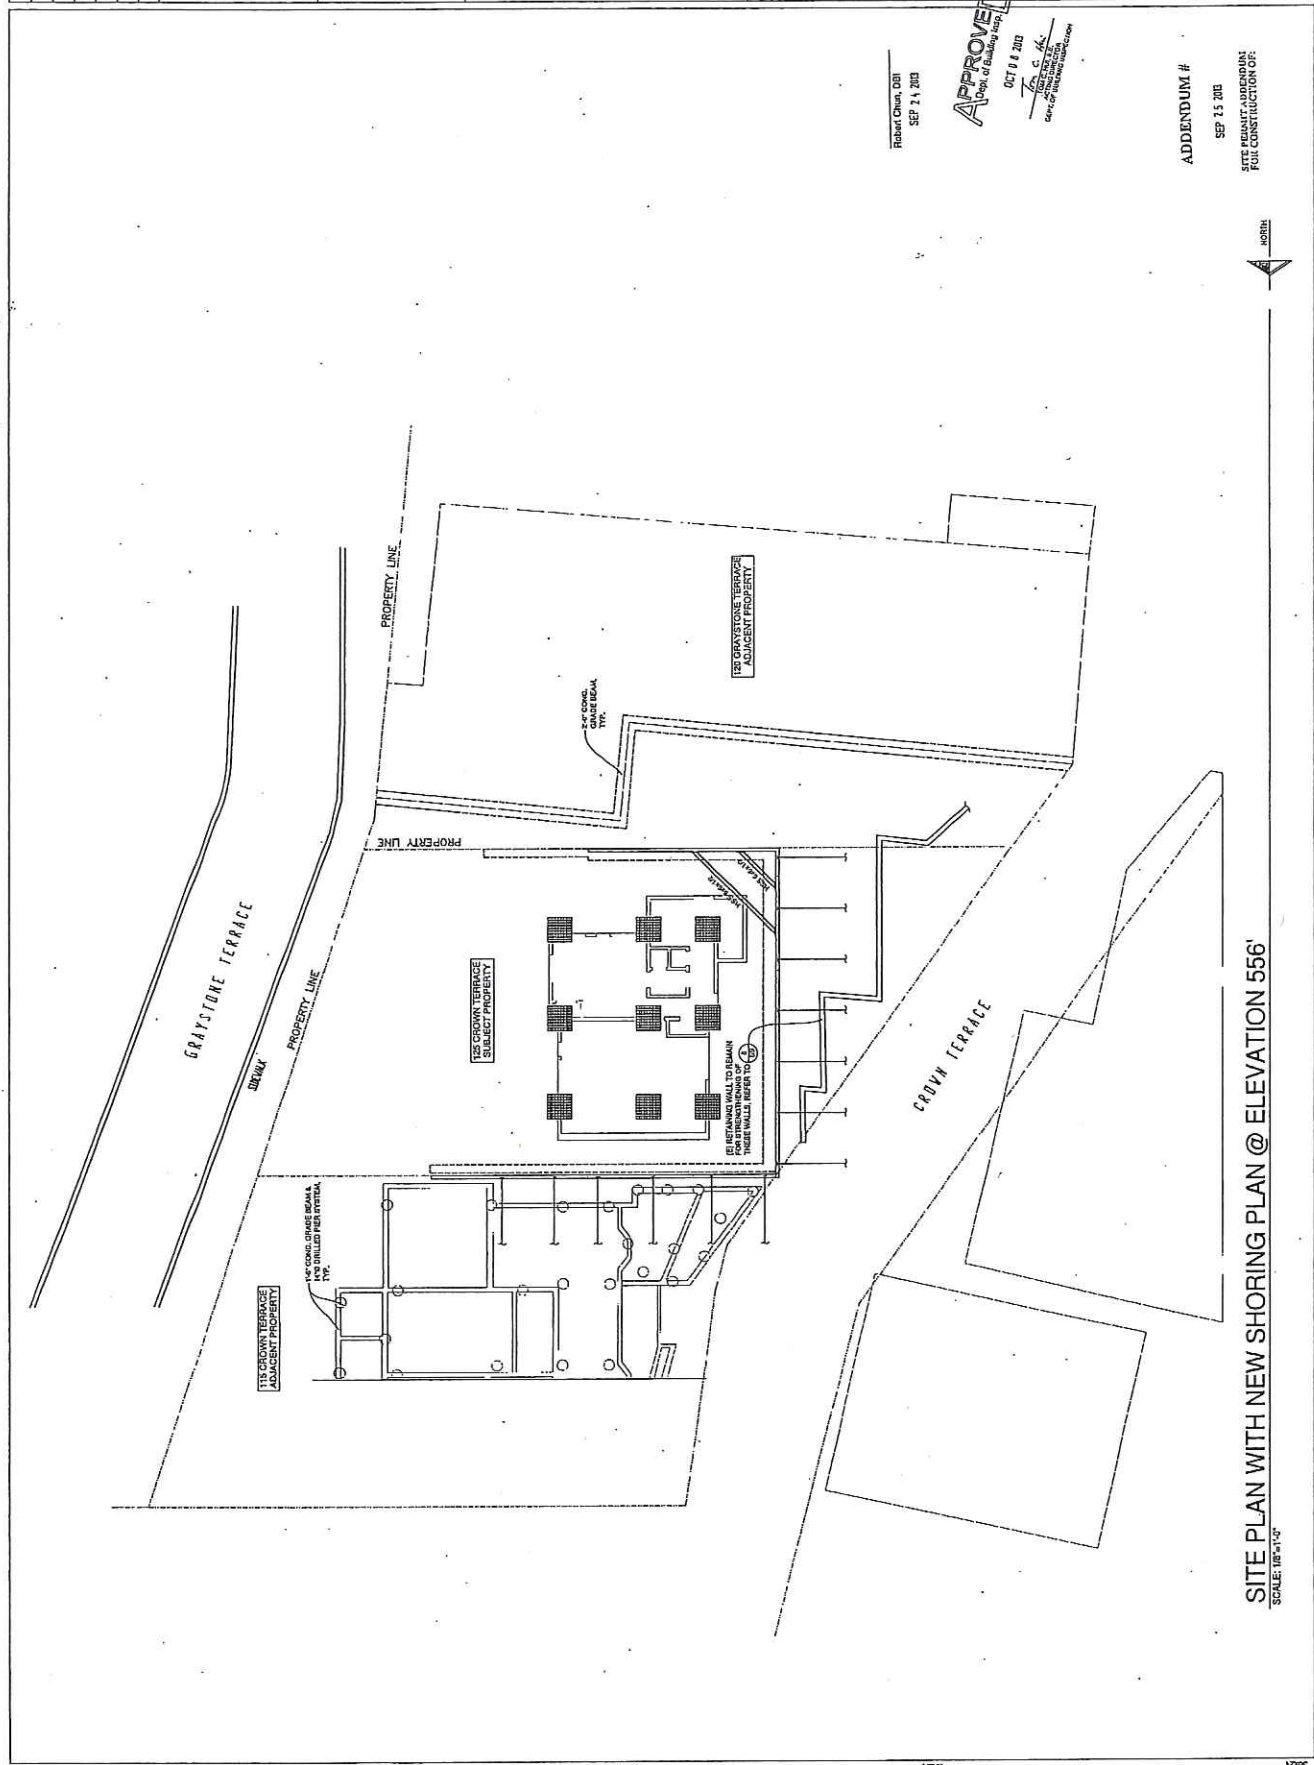
**SITE PLAN WITH NEW SHORING PLAN @ ELEVATION 556'**  
 SCALE: 1/8"=1'-0"

<b>SINGLE FAMILY RESIDENCE</b> <b>125 CROWN TERRACE</b> <b>SAN FRANCISCO, CALIFORNIA</b>		DATE: 08/30/13 SCALE: 1/8"=1'-0" DRAWN BY: R.S. JOB NO: 8180 SHEET: 3 OF 9 SHEETS
<b>TEMPORARY SHORING</b> <b>SUBJECT SITE PLAN W/</b> <b>SHORING PLAN &amp;</b> <b>NEIGHBOR FOUNDATION PLAN</b>		SANTS & URAUTIA STRUCTURAL ENGINEERS 2441 HANCOCK STREET SAN FRANCISCO, CA 94110 TELEPHONE (415) 643-7232 FAX (415) 643-7250
