*BIC Meeting of  
June 20, 2012*

RE: CAPSS Implementation Team Proposed Administrative Bulletins AB-098, AB-099, AB-100

- a. AB-098 (Draft 6) *Post-Earthquake Repair and Retrofit Requirements for Wood-Frame Residential Buildings with Three or More Dwelling Units*
- b. AB-099 (Draft 8) *Post-Earthquake Repair and Retrofit Requirements for Concrete Buildings*
- c. AB-100 (Draft 6) *Post-Earthquake Repair and Retrofit Requirements for One- and Two-Family Dwellings*

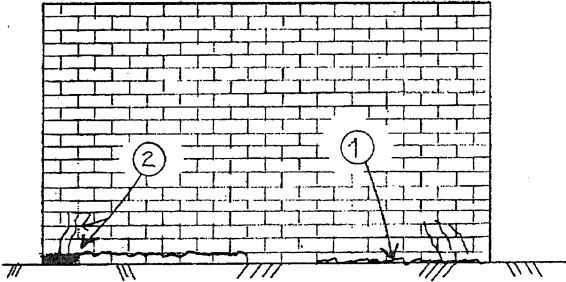
Level	Description of Damage	Typical Performance Restoration Measures
Insignificant  $\lambda_K = 1.0$ $\lambda_Q = 1.0$ $\lambda_D = 1.0$  $\mu_\Delta \leq 1.5$	<p><i>Criteria:</i></p> <ol style="list-style-type: none"> <li>1. Horizontal hairline cracks in bed joints at the heel of the wall.</li> <li>2. Possibly diagonally-oriented cracks and minor spalling at the toe of the wall.</li> </ol> <p><i>Typical Appearance:</i></p> <div style="text-align: center;">

This type of moderately ductile behavior has been experimentally observed in walls with  $L/h_{eff} \approx 1.7$  in which bed joint sliding and toe crushing strength capacities are similar. Damage occurs in the following sequence. First, flexural cracking occurs at the heel of the wall. Then diagonally-oriented cracks appear at the toe of the wall, typically accompanied by spalling and crushing of the units. In some cases, toe crushing is immediately followed by a steep inclined crack propagating upward from the toe. Next, sliding occurs along a horizontal bed joint near the base of the wall, accompanied in some cases by stair-stepped bed joint sliding at upper portions of the wall. With repeated cycles of loading, diagonal cracks increase. Eventually, crushing of the toes or excessive sliding leads to failure.

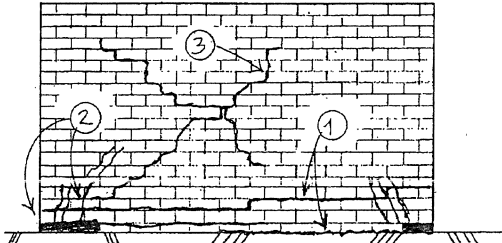
Level	Description of Damage	Typical Performance Restoration Measures
<p>Moderate</p> <p><math>\lambda_K = 0.9</math>  <math>\lambda_Q = 0.6^1</math>  <math>\lambda_D = 0.9</math></p> <p>1. As an alternative, calculate as <math>V_{bjs2}/V_{tc}</math></p> <p><math>\Delta/h_{eff} \leq 0.8\%</math></p>	<p><i>Criteria:</i></p> <ol style="list-style-type: none"> <li>1. Horizontal cracks/spalled mortar at bed joints at or near the base of the wall indicating that in-plane offset along the crack has occurred up to approximately 1/4".</li> <li>2. Possibly diagonally-oriented cracks and spalling at the toe of the wall. Cracks extend upward several courses.</li> <li>3. Possibly diagonally-oriented cracks at upper portions of the wall which may be in the units.</li> </ol> <p><i>Typical Appearance:</i></p>

<ul style="list-style-type: none"> <li>• Replace/drypack damaged units.</li> <li>• Repoint spalled mortar and open head joints.</li> <li>• Inject cracks and open head joints.</li> <li>• Install pins and drilled dowels in toe regions.</li> </ul> <p><math>\lambda_K^* = 1.0^1</math>  <math>\lambda_Q^* = 1.0^1</math>  <math>\lambda_D^* = 1.0^1</math></p> <p>1. In some cases, grout injection may actually increase strength, but decrease deformation capacity, by changing behavior from bed joint sliding to a less ductile behavior mode (see FEMA 307, Section 4.1.3).</p>

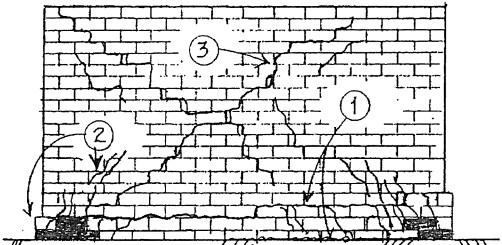
<p>Heavy</p> <p><math>\lambda_K = 0.8</math>  <math>\lambda_Q = 0.6^1</math>  <math>\lambda_D = 0.9</math></p> <p>1. As an alternative, calculate as <math>V_{bjs2}/V_{tc}</math></p> <p><math>\Delta/h_{eff} \leq 1.2\%</math></p>	<p><i>Criteria:</i></p> <ol style="list-style-type: none"> <li>1. Horizontal bed joint cracks near the base of the wall similar to Moderate, except width is up to approximately 1/2".</li> <li>2. Possibly extensive diagonally-oriented cracks and spalling at the toe of the wall. Cracks extend upward several courses.</li> <li>3. Possibly diagonally-oriented cracks up to 1/2" at upper portions of the wall.</li> </ol> <p><i>Typical Appearance:</i></p>

<ul style="list-style-type: none"> <li>• Replace/drypack damaged units.</li> <li>• Repoint spalled mortar and open head joints.</li> <li>• Inject cracks and open head joints.</li> <li>• Install pins and drilled dowels in toe regions.</li> </ul> <p><math>\lambda_K^* = 1.0^1</math>  <math>\lambda_Q^* = 1.0^1</math>  <math>\lambda_D^* = 1.0^1</math></p> <p>1. In some cases, grout injection may actually increase strength, but decrease deformation capacity, by changing behavior from bed joint sliding to a less ductile behavior mode (see FEMA 307, Section 4.1.3).</p>

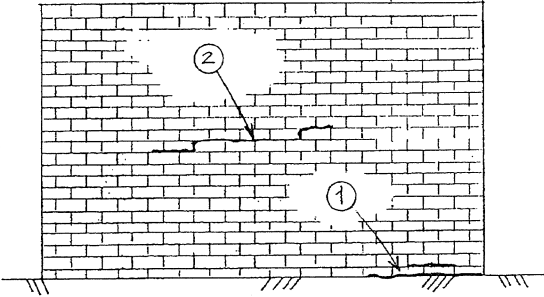
Level	Description of Damage	Typical Performance Restoration Measures
Insignificant $\lambda_K = 0.9$ $\lambda_Q = 1.0$ $\lambda_D = 1.0$  $\mu_\Delta \leq 1.5$	<p><i>Criteria:</i></p> <ol style="list-style-type: none"> <li>1. Horizontal hairline cracks in bed joints at the heel of the wall.</li> <li>2. Horizontal cracking on 1-3 cracks in the central portion of the wall. No offset along the crack has occurred and the crack plane is not continuous across the pier.</li> <li>3. No cracks in masonry units.</li> </ol> <p><i>Typical Appearance:</i></p> <div style="text-align: center;">

This type of behavior typically occurs in stockier walls with  $L/h_{eff} > 1.25$ . Based on laboratory testing, four steps can usually be identified. First, flexural cracking happens at the base of the wall, but it does not propagate all the way across the wall. This can also cause a series of horizontal cracks to form above the heel. Second, sliding occurs on bed joints in the central portion of the pier. Third, diagonal cracks form at the toe of the wall. Finally, large cracks form at the upper corners of the wall. Failure occurs when the triangular portion of wall above the crack rotates off the crack or the toe crushes so significantly that vertical load is compromised. Note that, for simplicity, the figures below only show a single crack, but under cyclic loading, multiple cracks stepping in each direction are possible.

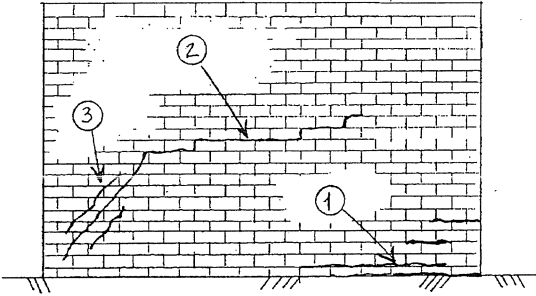
Level	Description of Damage	Typical Performance Restoration Measures
<p>Heavy</p> <p><math>\lambda_K = 0.8</math> <math>\lambda_Q = 0.8</math> <math>\lambda_D = 1.0</math></p> <p><math>\Delta/h_{eff} \leq 0.3\%</math></p>	<p><i>Criteria:</i></p> <ol style="list-style-type: none"> <li>Horizontal hairline cracks in bed joints at the heel of the wall.</li> <li>Horizontal cracking on 1-3 cracks in the central portion of the wall. Some offset along the crack may have occurred.</li> <li>Diagonal cracking at the toe of the wall, likely to be through the units, and some of units may be spalled.</li> </ol> <p><i>Typical Appearance:</i></p>

<p>Replacement or enhancement is required for full restoration of seismic performance.</p> <p>For <u>partial</u> restoration of performance:</p> <ul style="list-style-type: none"> <li>Repoint spalled mortar.</li> <li>Inject cracks.</li> </ul> <p><math>\lambda_K^* = 0.9</math> <math>\lambda_Q^* = 0.9</math> <math>\lambda_D^* = 1.0</math></p>

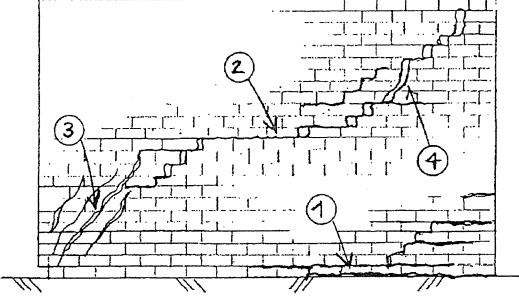
<p>Extreme</p> <p><math>\lambda_K = 0.6</math> <math>\lambda_Q = 0.6</math> <math>\lambda_D = 0.9</math></p> <p><math>\Delta/h_{eff} \leq 0.9\%</math></p>	<p><i>Criteria:</i></p> <ol style="list-style-type: none"> <li>Horizontal hairline cracks in bed joints at the heel of the wall.</li> <li>Horizontal cracking on 1 or more cracks in the central portion of the wall. Offset along the crack will have occurred.</li> <li>Diagonal cracking at the toe of the wall, likely to be through the units, and some of units may be spalled.</li> <li>Large cracks have formed at upper portions of the wall. In walls with aspect ratios of <math>L/h_{eff} &gt; 1.5</math>, these cracks will be diagonally oriented; for more slender piers, cracks will be more vertical and will go through units.</li> </ol> <p><i>Typical Appearance:</i></p>

<p>Replacement or enhancement is required for full restoration of seismic performance.</p> <p>For <u>partial</u> restoration of performance:</p> <ul style="list-style-type: none"> <li>Replace/drypack damaged units.</li> <li>Repoint spalled mortar.</li> <li>Inject cracks.</li> <li>Install pins and drilled dowels in toe regions.</li> </ul> <p><math>\lambda_K^* = 0.9</math> <math>\lambda_Q^* = 0.8</math> <math>\lambda_D^* = 1.0</math></p>

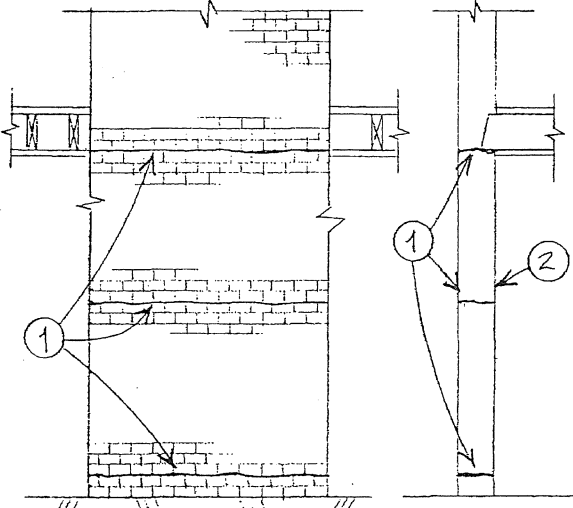
Level	Description of Damage	Typical Performance Restoration Measures
<p>Insignificant</p> <p>For out-of-plane loads: <math>\lambda_{h/t} = 1.0</math></p> <p>For in-plane modes given previously, assume out-of-plane damage leads to Moderate damage for URM2B and Insignificant damage for all other modes.</p>	<p><i>Criteria:</i></p> <ol style="list-style-type: none"> <li>1. Hairline cracks at floor/roof lines and midheight of stories.</li> <li>2. No out-of-plane offset or spalling of mortar along cracks.</li> </ol> <p><i>Typical Appearance:</i></p>

Out-of-plane failures are common in URM buildings. Usually they occur due to the lack of adequate wall ties, as discussed in Table 7-1. When ties are adequate, the wall may fail due to out-of-plane bending between floor levels. One mode of failure observed in experiments is rigid-body rocking motion occurring on three cracks: one at the top of the wall, one at the bottom, and one at midheight. As rocking increases, the mortar and masonry units at the crack locations can be degraded, and residual offsets can occur at the crack planes. The ultimate limit state is that the walls rock too far and overturn. Important variables are the vertical stress on the wall and the height-to-thickness ratio of the wall. Thus, walls at the top of buildings and slender walls are more likely to suffer damage.

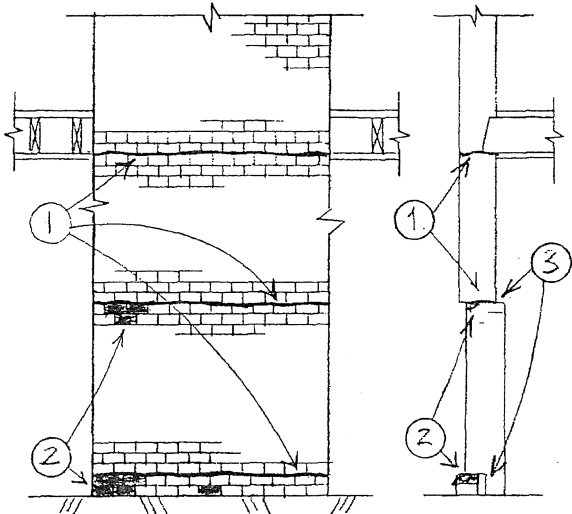
Level	Description of Damage	Typical Performance Restoration Measures
Slight	Not used.	
Moderate  For <u>out-of-plane</u> loads: $\lambda_{h/i} = 0.9$  For <u>in-plane</u> modes, see Insignificant damage	<p><i>Criteria:</i></p> <ol style="list-style-type: none"> <li>Cracks at floor/roof lines and midheight of stories may have mortar spalls up to full depth of joint and possibly;</li> <li>Out-of-plane offsets along cracks of up to 1/8".</li> </ol> <p><i>Typical Appearance:</i> See Insignificant damage above.</p>	<ul style="list-style-type: none"> <li>Repoint spalled mortar:</li> <li>For <u>out-of-plane</u> loads: <math>\lambda_{h/i} = 1.0</math></li> <li>For <u>in-plane</u> loads: use Moderate for URM2B and Insignificant for all other modes.</li> </ul>
Heavy  For <u>out-of-plane</u> loads: $\lambda_{h/i} = 0.6$  For <u>in-plane</u> modes given previously, assume out-of-plane damage leads to <i>Heavy</i> for all other modes.	<p><i>Criteria:</i></p> <ol style="list-style-type: none"> <li>Cracks at floor/roof lines and midheight of stories may have mortar spalls up to full depth of joint.</li> <li>Spalling and rounding at edges of units along crack plane.</li> <li>Out-of-plane offsets along cracks of up to 1/2".</li> </ol> <p><i>Typical Appearance:</i></p>

<p>Replacement or enhancement is required for full restoration of seismic performance.</p> <p>For <u>partial</u> restoration of out-of-plane performance:</p> <ul style="list-style-type: none"> <li>Replace/drypack damaged units</li> <li>Repoint spalled mortar <math>\lambda_{h/i} = 0.8</math></li> </ul>

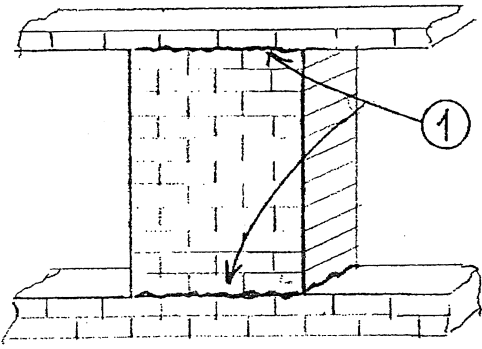
Level	Description of Damage	Typical Performance Restoration Measures
Insignificant  $\lambda_K = 0.8$ $\lambda_Q = 1.0$ $\lambda_D = 1.0$  $\mu_\Delta \leq 1.5$	<p><i>Criteria:</i></p> <ul style="list-style-type: none"> <li>• Hairline cracks/spalled mortar in bed joints at top and bottom of pier.</li> </ul> <p><i>Typical Appearance:</i></p>

Rocking-critical piers form horizontal flexural cracks at the top and bottom of piers. Because the cracks typically close as the pier comes back to rest at the end of ground shaking, these cracks can be quite subtle when only a few cycles of rocking have occurred and when pier drift ratios during shaking were small. As damage increases, softening of the pier can occur due to cracking, and the pier may begin to “walk” out-of-plane at the top and bottom. At the highest damage levels, crushing of units at the corners can occur.

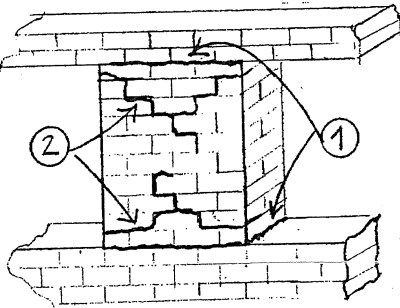
Level	Description of Damage	Typical Performance Restoration Measures
Slight	Not used.	
Moderate	<p><i>Criteria:</i></p> <ol style="list-style-type: none"> <li>1. Hairline cracks/spalled mortar in bed joints at top and bottom of pier.</li> <li>2. Possible hairline cracking/spalled mortar in bed joints within piers.</li> </ol> <p><i>Typical Appearance:</i></p>

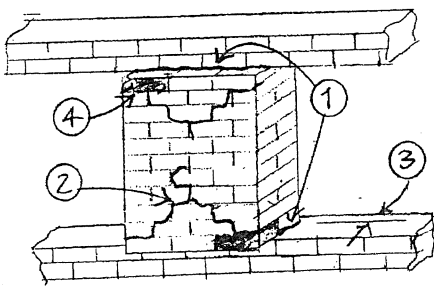
<p>Replacement or enhancement is required for full restoration of seismic performance.</p> <p>For partial restoration of performance:</p> <ul style="list-style-type: none"> <li>• Repoint spalled mortar.</li> </ul> <p> <math>\lambda_K^* = 0.8</math>  <math>\lambda_Q^* = 0.9</math>  <math>\lambda_D^* = 1.0</math> </p>
Heavy	<p><i>Criteria:</i></p> <ol style="list-style-type: none"> <li>1. Hairline cracks/spalled mortar in bed joints at top and bottom of pier, plus one or more of:</li> <li>2. Hairline cracking/spalled mortar in bed joints within piers, but bed joints typically do not open.</li> <li>3. Possible out-of-plane or in-plane movement at top and bottom of piers ("walking").</li> <li>4. Crushed/spalled bricks at corners of piers.</li> </ol> <p><i>Typical Appearance:</i></p>

<p>Replacement or enhancement is required for full restoration of seismic performance.</p> <p>For partial restoration of performance:</p> <ul style="list-style-type: none"> <li>• Replace/drypack damaged units</li> <li>• Repoint spalled mortar</li> <li>• Inject cracks</li> </ul> <p> <math>\lambda_K^* = 0.8</math>  <math>\lambda_Q^* = 0.9</math>  <math>\lambda_D^* = 1.0</math> </p>

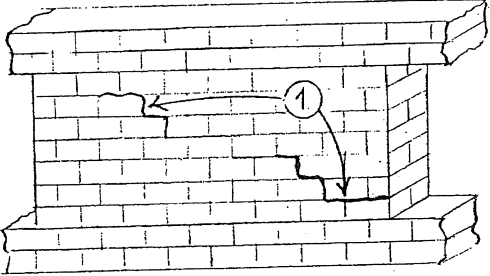
Level	Description of Damage	Typical Performance Restoration Measures
Insignificant  $\lambda_K = 0.9$ $\lambda_Q = 0.9$ $\lambda_D = 1.0$  $\mu_\Delta \leq 1.5$	<p><i>Criteria:</i></p> <ol style="list-style-type: none"> <li>1. Hairline cracks/spalled mortar in head and bed joints either on a horizontal plane or in a stair-stepped fashion have been initiated, but no offset along the crack has occurred and the crack plane or stair-stepping is not continuous across the pier.</li> <li>2. No cracks in masonry units.</li> </ol> <p><i>Typical Appearance:</i></p>

In this type of behavior, sliding occurs on bed joints. Commonly observed both in the field and in experimental tests, there are two basic forms: sliding on a horizontal plane, and a stair-stepped diagonal crack where the head joints open and close to allow for movement on the bed joint. Note that, for simplicity, the figures below only show a single crack, but under cyclic loading, multiple cracks stepping in each direction are possible. Pure bed joint sliding is a ductile mode with significant hysteretic energy absorption capability. If sliding continues without leading to a more brittle mode such as toe crushing, then gradual degradation of the cracking region occurs until instability is reached. Theoretically possible, but not widely reported, is the case of stair-stepped cracking when sliding goes so far that an upper brick slides off a lower unit.

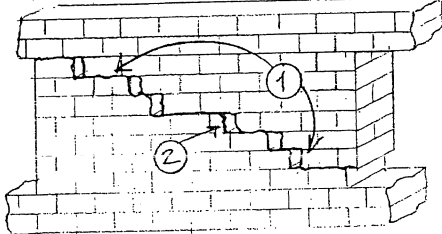
Level	Description of Damage	Typical Performance Restoration Measures
Slight	Not used.	
Moderate  $\lambda_K = 0.8$ $\lambda_Q = 0.6^*$ $\lambda_D = 1.0$  *As an alternative, calculate as $V_{bjs2}/V_{bjs1}$  $\Delta/h_{eff} \leq 0.4\%$	<p><i>Criteria:</i></p> <ol style="list-style-type: none"> <li>Horizontal cracks/spalled mortar at bed joints indicating that in-plane offset along the crack has occurred and/or opening of the head joints up to approximately 1/4", creating a stair-stepped crack pattern.</li> <li>5% of courses or fewer have cracks in masonry units.</li> </ol> <p><i>Typical Appearance:</i></p>

<p>Replacement or enhancement is required for full restoration of seismic performance.</p> <p>For partial restoration of performance:</p> <ul style="list-style-type: none"> <li>Repoint spalled mortar and open head joints.</li> <li>Inject cracks and open head joints</li> </ul> <p><math>\lambda_K^* = 0.8</math> <math>\lambda_Q^* = 0.8^*</math> <math>\lambda_D^* = 1.0^*</math></p> <p>*In some cases, grout injection may actually increase strength, but decrease deformation capacity, by changing behavior from bed joint sliding to a less ductile behavior mode (see FEMA 307, Section 4.1.3).</p>

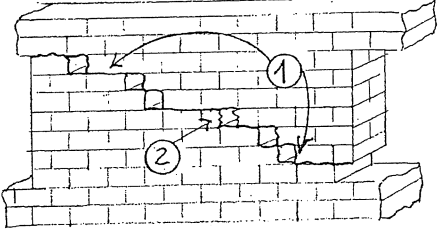
Heavy  $\lambda_K = 0.6$ $\lambda_Q = 0.6^*$ $\lambda_D = 0.9$  *As an alternative, calculate as $V_{bjs2}/V_{bjs1}$  $\Delta/h_{eff} \leq 0.8\%$	<p><i>Criteria:</i></p> <ol style="list-style-type: none"> <li>Horizontal cracks/spalled mortar on bed joints indicating that in-plane offset along the crack has occurred and/or opening of the head joints up to approximately 1/2", creating a stair-stepped crack pattern.</li> <li>5% of courses or fewer have cracks in masonry units.</li> </ol> <p><i>Typical Appearance:</i></p>

<p>Replacement or enhancement is required for full restoration of seismic performance.</p> <p>For partial restoration of performance:</p> <ul style="list-style-type: none"> <li>Repoint spalled mortar and open head joints.</li> <li>Inject cracks and open head joints.</li> </ul> <p><math>\lambda_K^* = 0.8</math> <math>\lambda_Q^* = 0.8^*</math> <math>\lambda_D^* = 1.0^*</math></p> <p>*In some cases, grout injection may actually increase strength, but decrease deformation capacity, by changing behavior from bed joint sliding to a less ductile behavior mode (see FEMA 307, Section 4.1.3).</p>

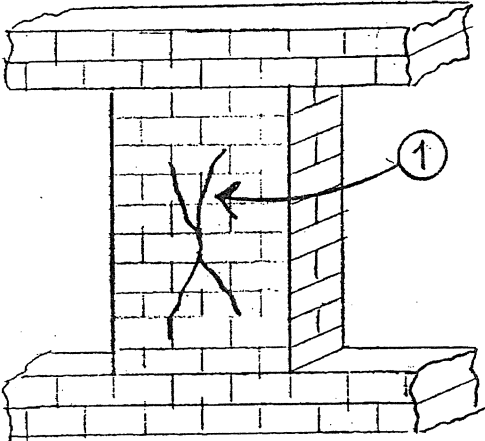
Level	Description of Damage	Typical Performance Restoration Measures
Insignificant  $\lambda_K = 1.0$ $\lambda_Q = 1.0$ $\lambda_D = 1.0$  $\mu_\Delta \leq 1$	<p><i>Criteria:</i> 1. Hairline diagonal cracks in masonry units in fewer than 5% of courses.</p> <p><i>Typical Appearance:</i></p>

Typical diagonal tension cracking—resulting from strong mortar, weak units, and high compressive stress—can be identified by diagonal cracks (“X” cracks) that propagate through the units. In many cases, the cracking is sudden, brittle, and vertical load capacity drops quickly. The cracks may then extend to the toe and the triangles above and below the crack separate. In a few cases, the load drop may be more gradual with cracks increasing in size and extent with each cycle. A second form of diagonal tension cracking also has been experimentally observed with weak mortar, strong units and low compressive stress where the cracks propagate in a stair-stepped manner in head and bed joints. The first (typical) case is shown below.

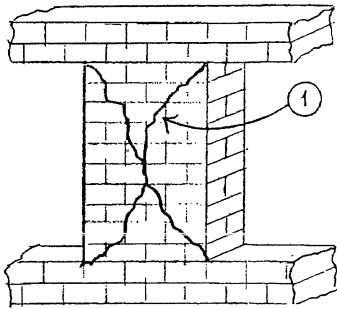
Level	Description of Damage	Typical Performance Restoration Measures
Slight	Not used.	
<p>Moderate</p> <p><math>\lambda_K = 0.8</math> <math>\lambda_Q = 0.9</math> <math>\lambda_D = 1.0</math></p> <p><math>\mu_\Delta \approx 1-1.5</math></p>	<p><i>Criteria:</i></p> <ol style="list-style-type: none"> <li>Diagonal cracks in pier, many of which go through masonry units, with crack widths below 1/4".</li> <li>Diagonal cracks reach or nearly reach corners.</li> <li>No crushing/spalling of pier corners.</li> </ol> <p><i>Typical Appearance:</i></p>

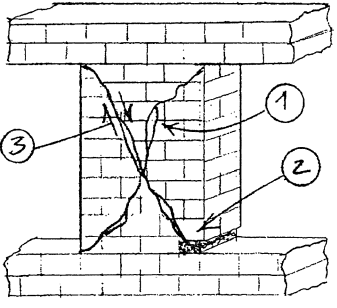
<ul style="list-style-type: none"> <li>Repoint spalled mortar.</li> <li>Inject cracks.</li> </ul> <p><math>\lambda_K^* = 0.8</math> <math>\lambda_Q^* = 1.0</math> <math>\lambda_D^* = 1.0</math></p>
<p>Heavy</p> <p><math>\lambda_K = 0.4</math> <math>\lambda_Q = 0.8</math> <math>\lambda_D = 0.7</math></p> <p><math>\mu_\Delta &gt; 1.5</math></p>	<p><i>Criteria:</i></p> <ol style="list-style-type: none"> <li>Diagonal cracks in pier, many of which go through masonry units, with crack widths over 1/4". Damage may also include:</li> <li>Some minor crushing/spalling of pier corners and/or</li> <li>Minor movement along or across crack plane.</li> </ol> <p><i>Typical Appearance:</i></p>

<p>Replacement or enhancement is required for full restoration of seismic performance.</p> <p>For <u>partial</u> restoration of performance:</p> <ul style="list-style-type: none"> <li>Replace/drypack damaged units.</li> <li>Repoint spalled mortar.</li> <li>Inject cracks.</li> </ul> <p><math>\lambda_K^* = 0.8</math> <math>\lambda_Q^* = 0.8</math> <math>\lambda_D^* = 1.0</math></p>
